The Kumamoto Earthquake Investigation: A Preliminary Report

By
Woody Epstein
Takanao Nishimoto
Koji Okumura
Sam Swan
Peter Yanev

April 29, 2016

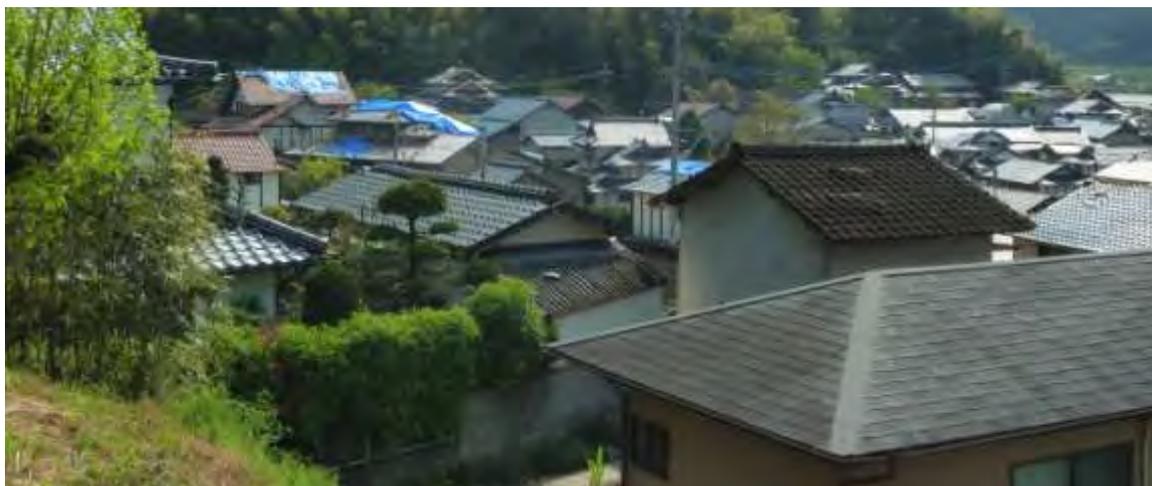
A view of a residential area at the foot of the hills in the Town of Mashiki. All of the damaged houses are wood-frame construction.

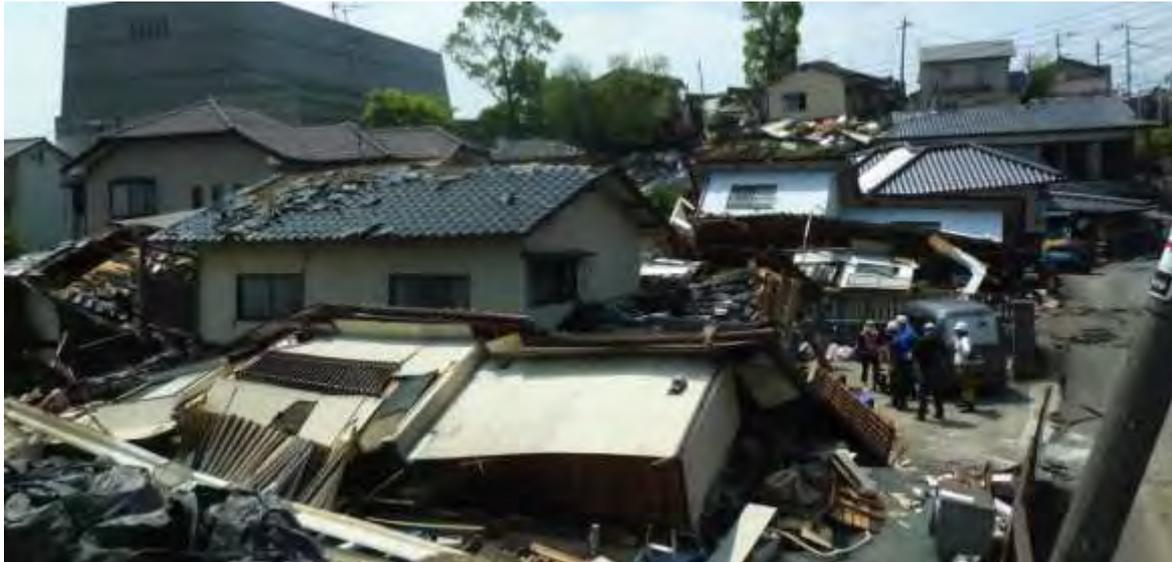
Another view of a heavily damaged residential area of Mashiki. All of the houses in the photo are wood frame; most are relatively new.

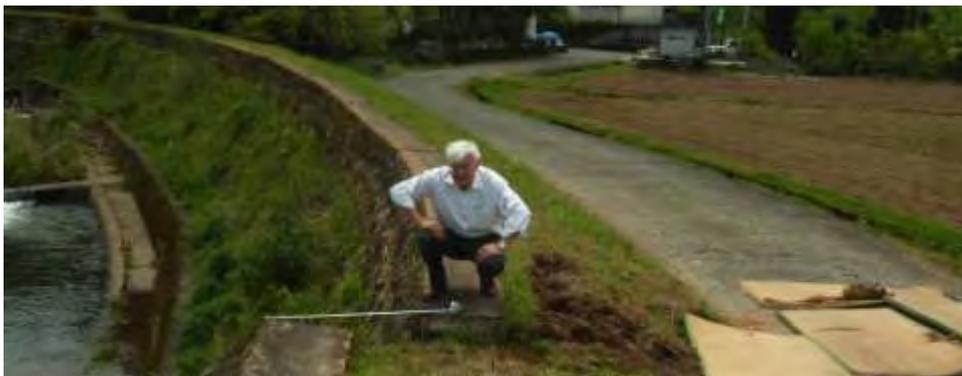
Faulting, along the Futagawa fault through a hilly residential area of Mashiki. At this location the fault has offset a retaining wall about 4 feet (1.2m). Houses founded right on top of the fault were typically completely destroyed. Nearby wood frame houses, not directly on the fault, had various degrees of structural damage – from light to extreme, including many collapses.

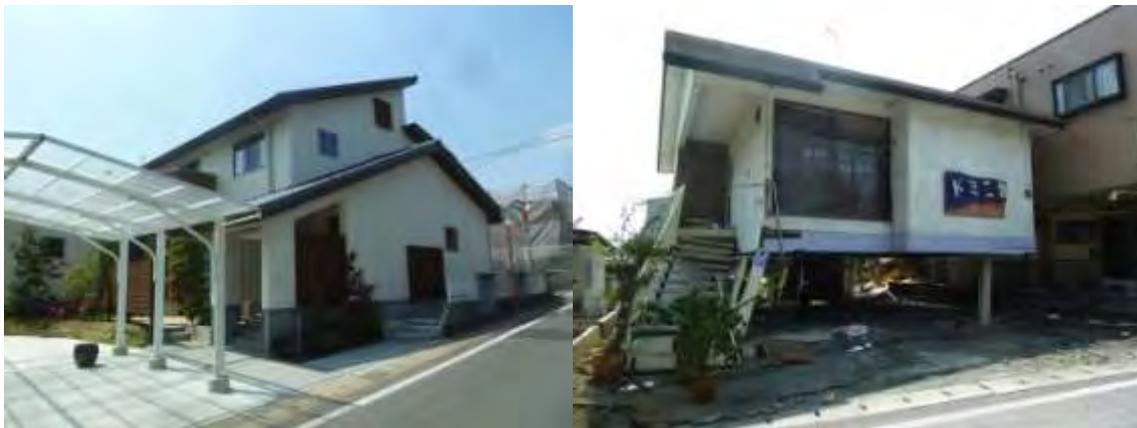
On the left is a practically undamaged house not far away from a severely damaged house (on the right). The difference in performance here is primarily due to the lack of bracing in the garage in the house on the right. Note the unbroken window on the second floor.

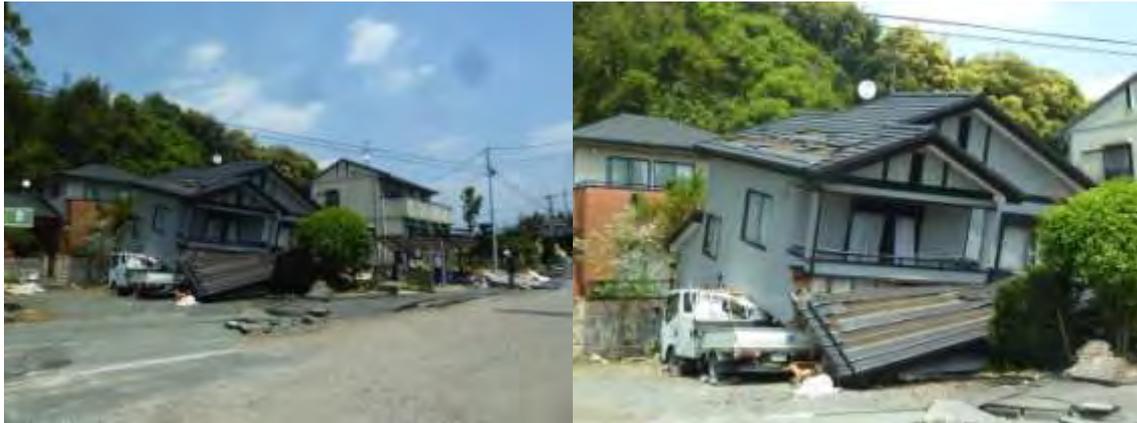
Another house with too many openings (windows) and not enough walls on the ground floor. Note the relatively undamaged houses behind and on the right of the collapsed house.

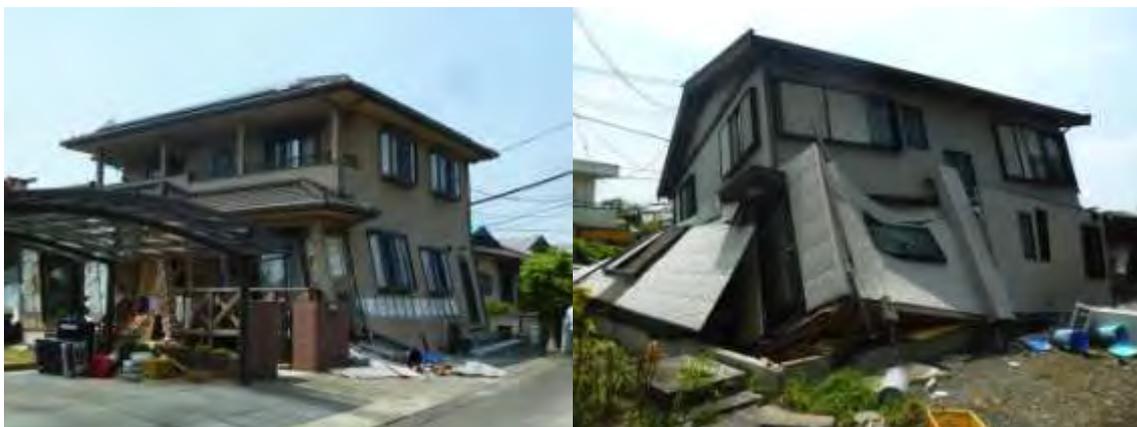
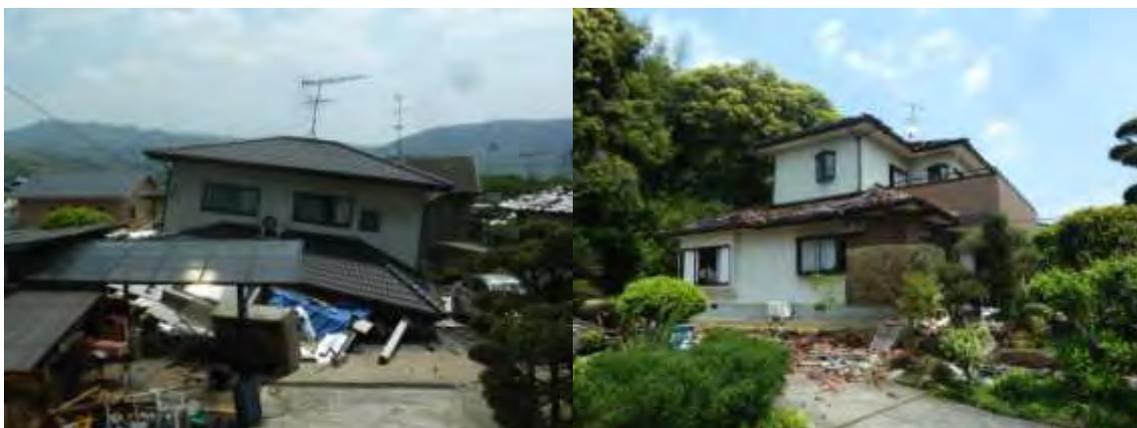
Other severely damaged houses in Mashiki. Most of the damage that occurred was due to too many windows and not enough strength in the lower floor walls. That additional strength can be easily provided with the bracing provided by a few more well-nailed plywood sheets.

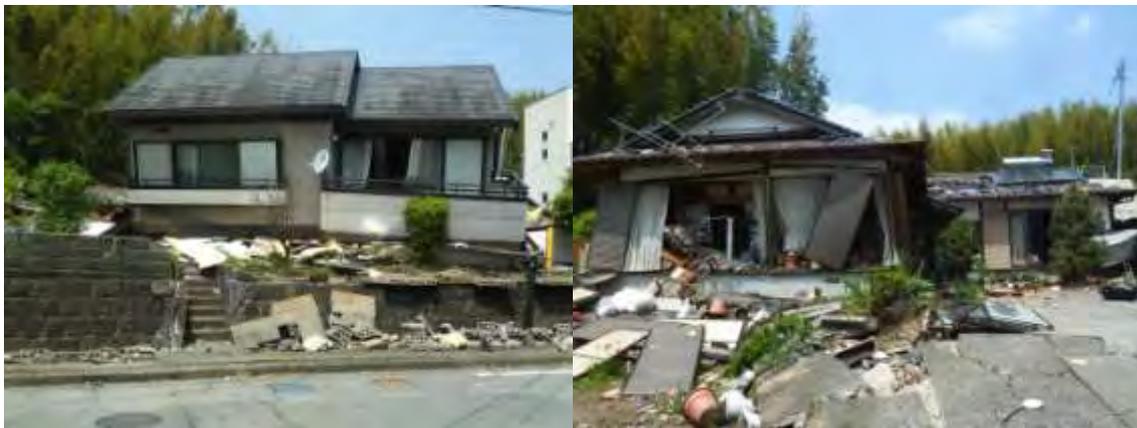
Much of the damage to houses in the hills was also due to ground failures around the house foundations. That was caused by minor local land sliding and/or the slumping of inadequately compacted fills around the houses. These types of fills are necessary to create level pads for the house foundations, as is the common practice along the West Coast of the US and Canada. What was surprising in Mashiki was the extent of such failures. The likely cause of this unusually high damage is the very strong shaking in the immediate vicinity of the fault.

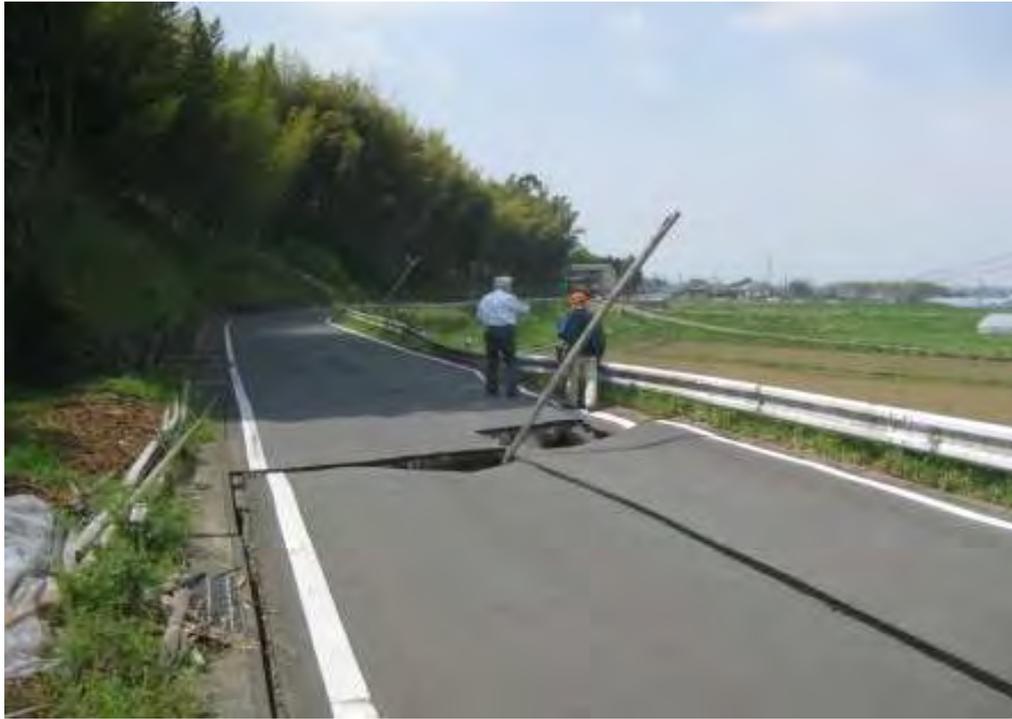
The surface trace of the fault on the southern side of the Mashiki Valley created offsets in roadways and retaining walls and in a few homes. The photo looks west along the Futogawa fault toward Kumamoto.

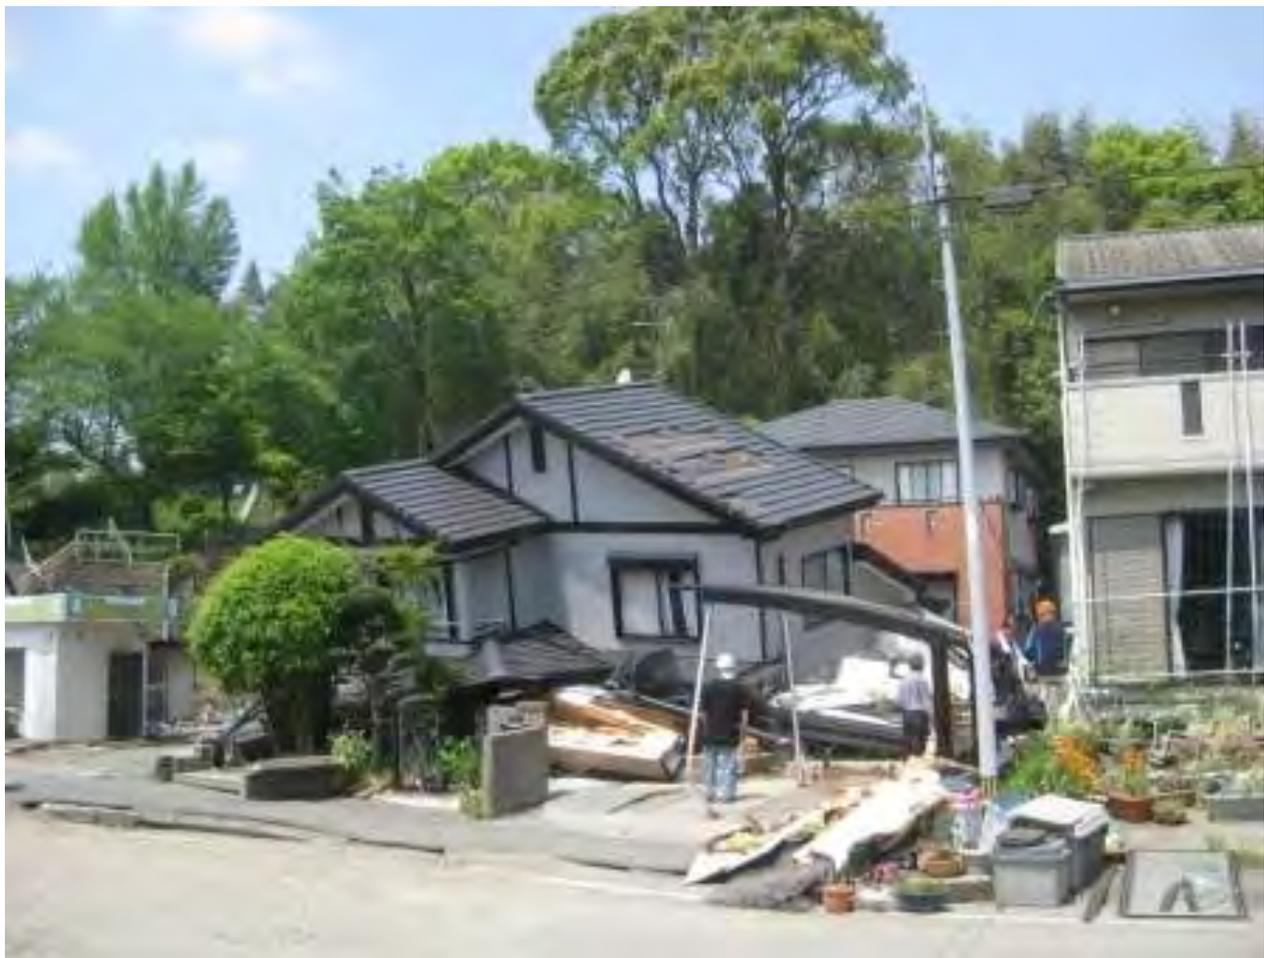
The most serious damage was concentrated on the north side of the Mashiki Valley where the soft soil meets the volcanic rock of the hills. As an estimate roughly 10% of all homes and small business structures were a total loss through partial or total collapse.

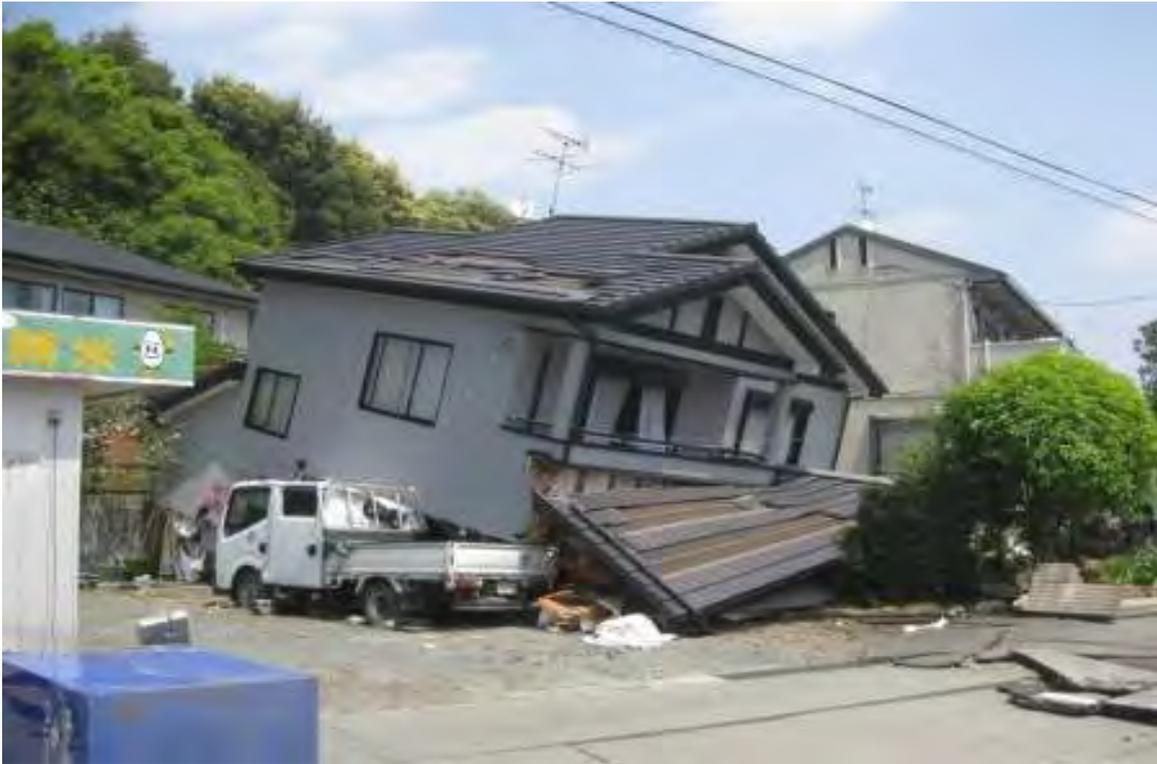
Collapse of homes was often attributable to soft first stories containing garages where large door openings provided no restraint against lateral loads.

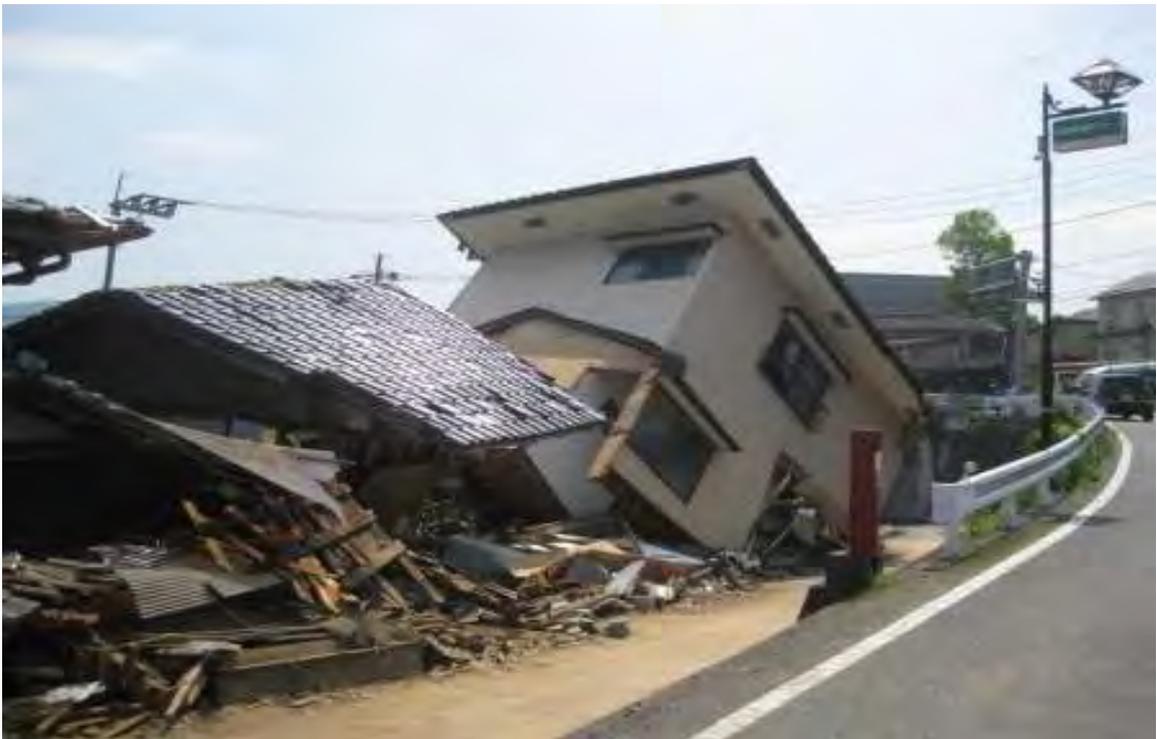
Soil slumping or spreading caused some collapses, as with this home that tilted toward the nearby stream bed.

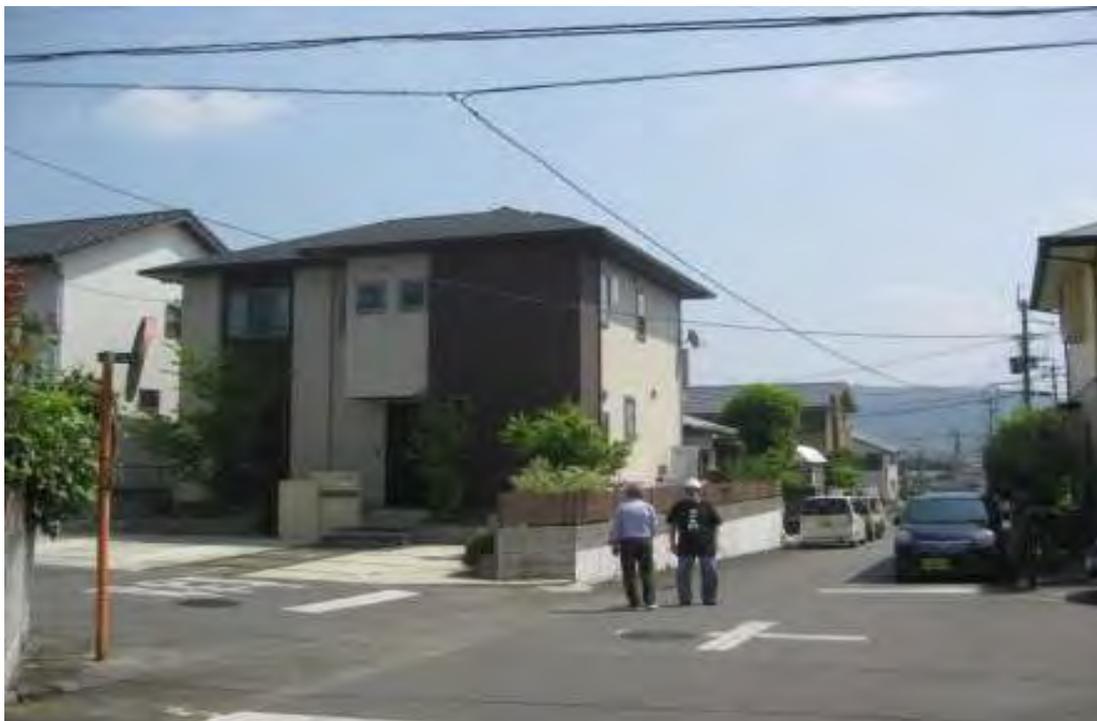
Serious damage was sporadic in the newer homes of the residential area on the hilltop near the Mashiki strong motion instrument. Close inspection however revealed that most homes required some level of repair. Damage became more extreme proceeding down the hill into the older district atop softer soil.

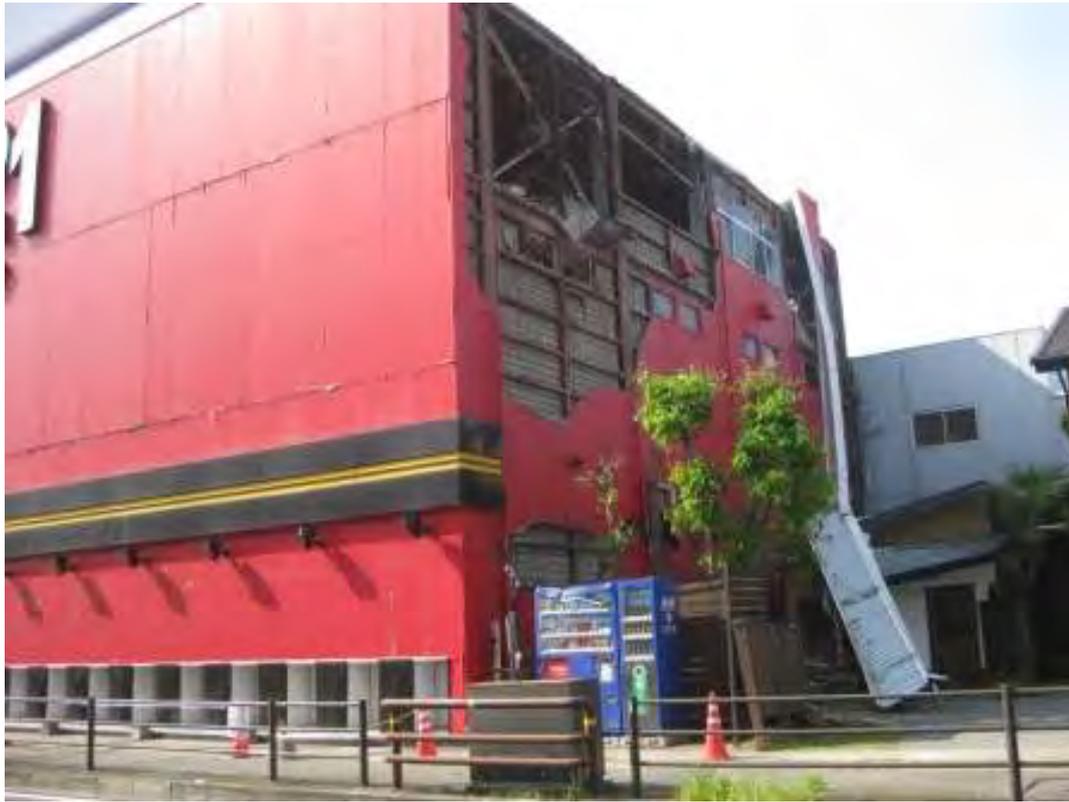
As the city of Kumamoto was entered going from Mashiki east-to-west, visible damage in buildings declined becoming sporadic. Serious affects such as loss of this masonry siding from a steel-frame building represented less than 1% of structures.

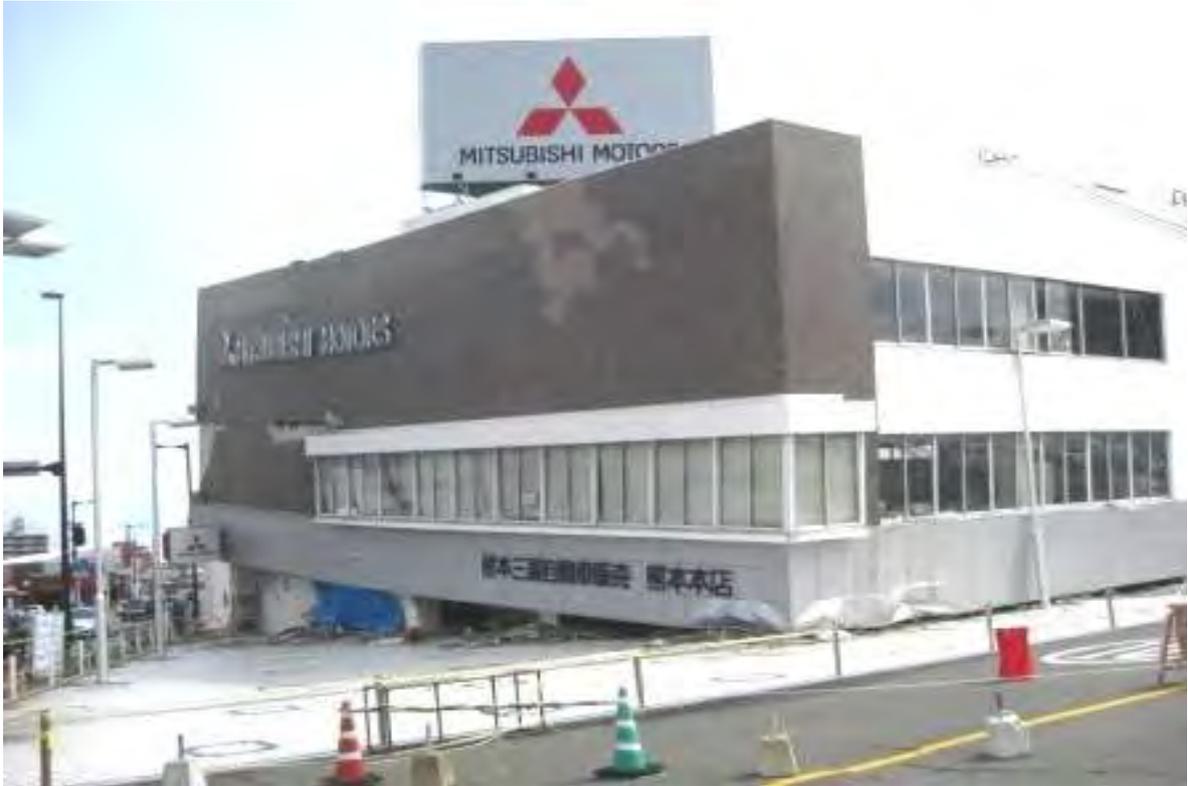
One of the few notable exceptions of serious building damage was the soft storey collapse of the Mitsubishi dealership show room in south central Kumamoto. Lack of adequate ties around vertical rebar in the concrete columns appeared to be the root cause. The photo was taken just before the team was asked to leave by the Mitsubishi sales manager.

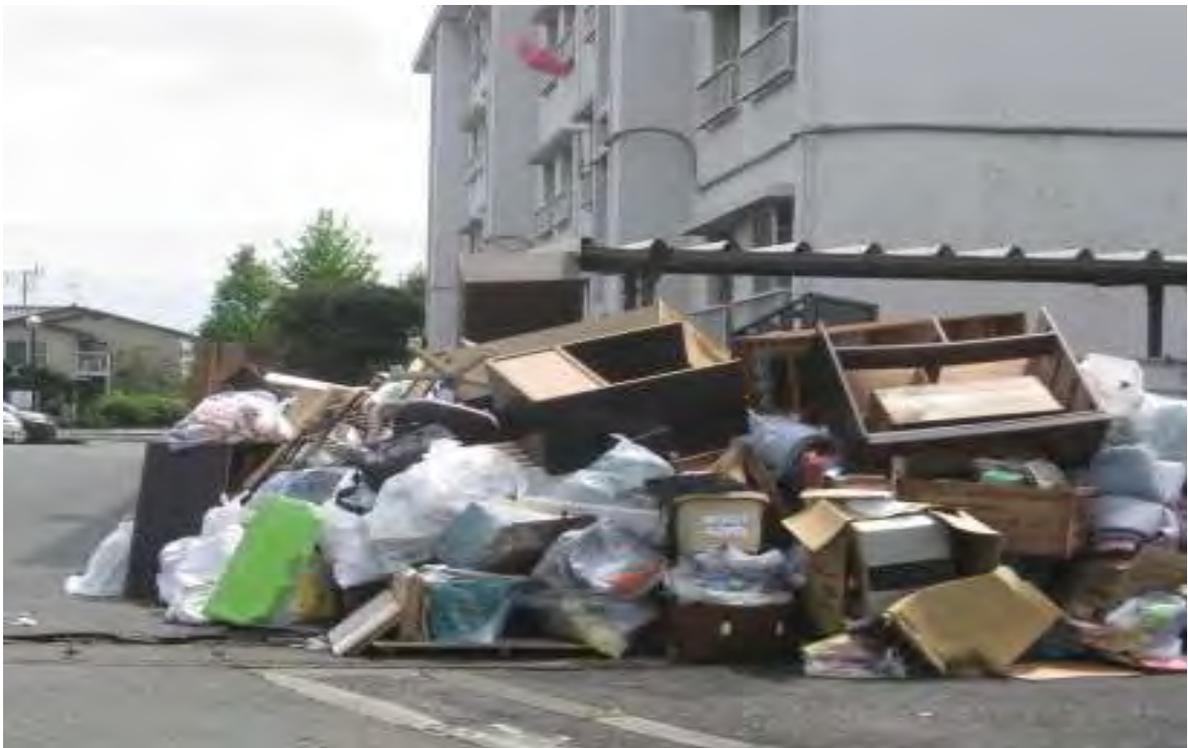
The universal indicator of earthquake damage in central Kumamoto were the piles of damaged furniture, appliances and collapsed perishables stacked in front of every large apartment complex, indicating the degree of damage to unrestrained internal fixtures.

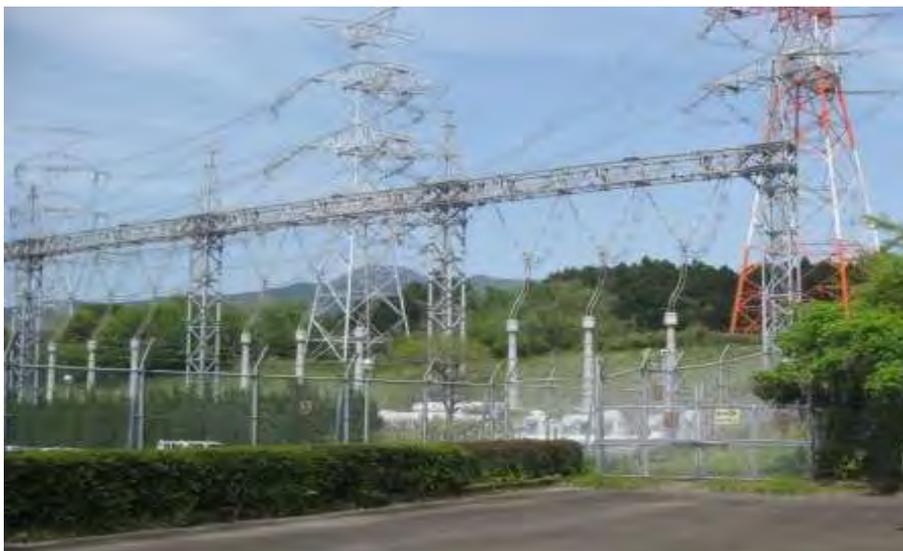
Electric power to the greater Kumamoto area is supplied over 220 and 500 kilovolt transmission lines into major substations such as this one near Kukuchi. The photo shows the entry of 500-kV lines dropping into the steel truss frame with cables dropping to the tall ceramic insulators of circuit breakers.

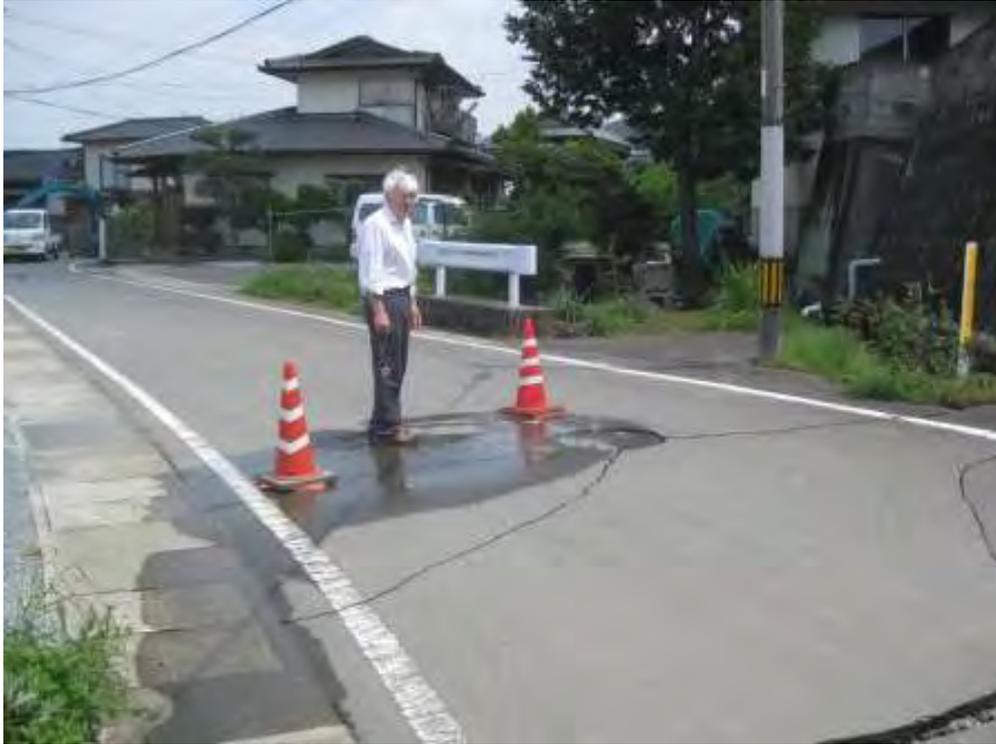
Rupture of underground water mains delays restoration in soft soil areas subject to severe shaking. The photo shows water seeping from a break on the fault trace on the north side of the Mashiki Valley.

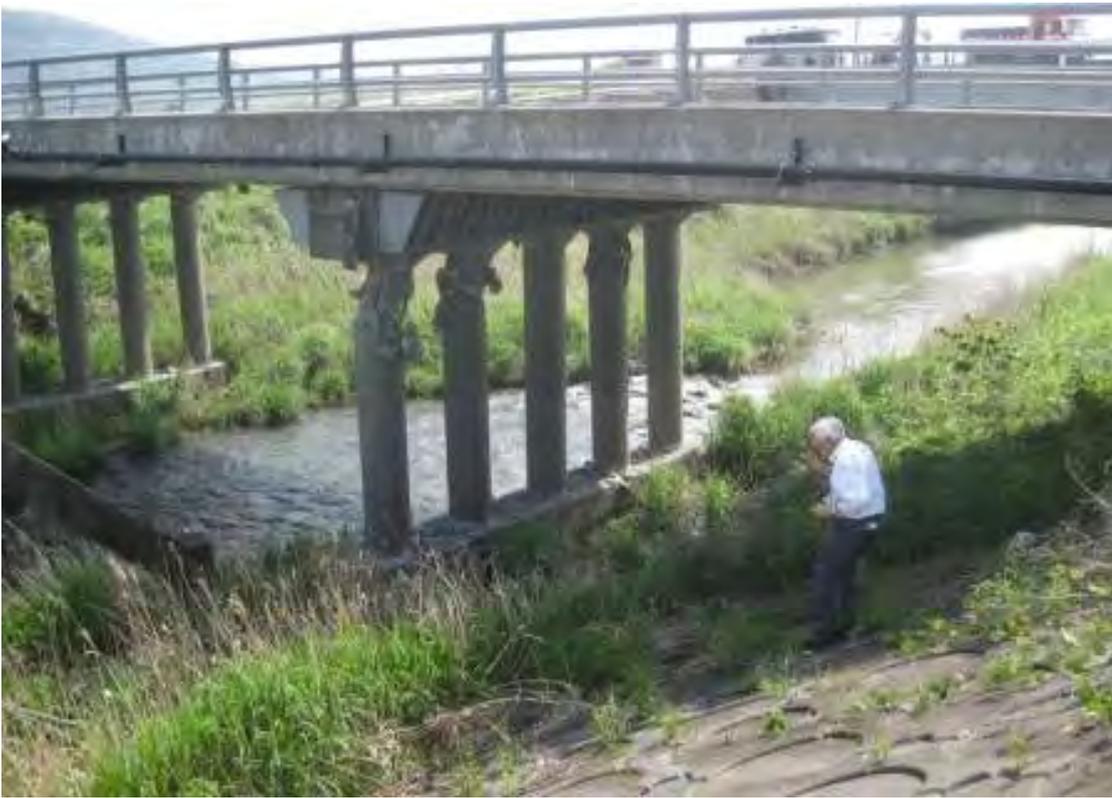
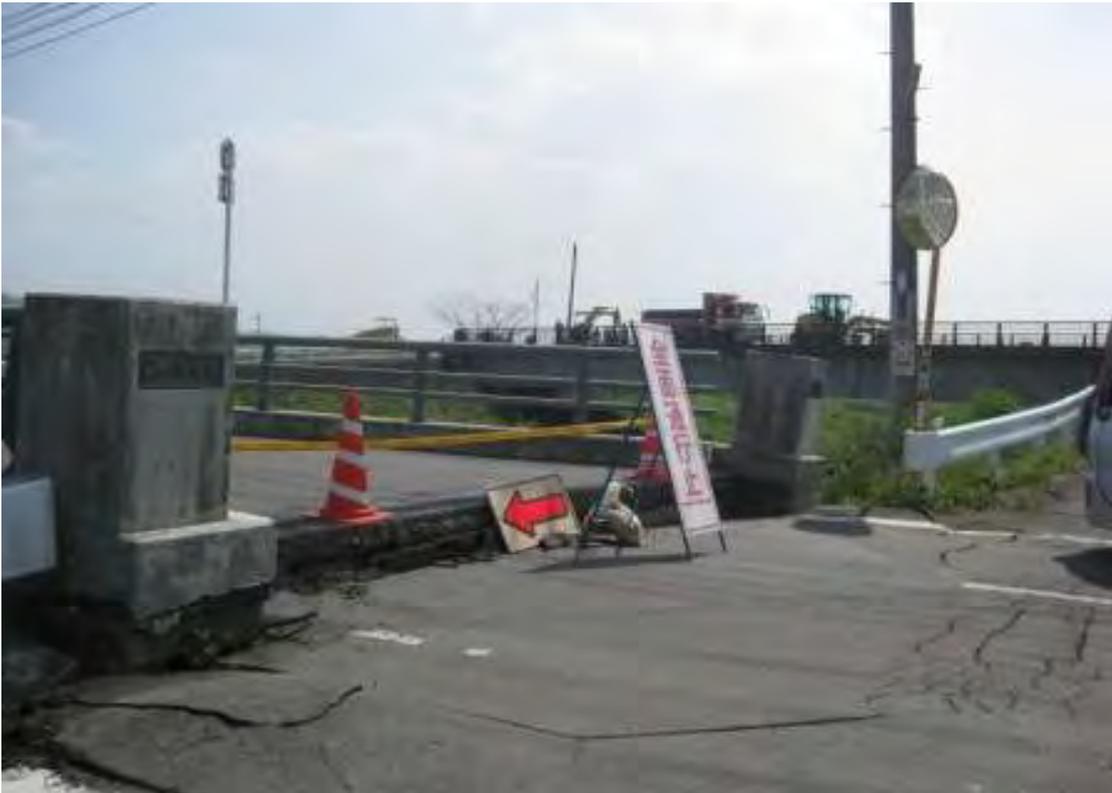
Traffic arteries were closed following the earthquakes due to bridge and overpass damage including failure in columns (upper photo) and slumping where bridges meet abutments (lower photo). Closures divert traffic to alternative routes creating major delays that affect the population far beyond the area of earthquake damage.

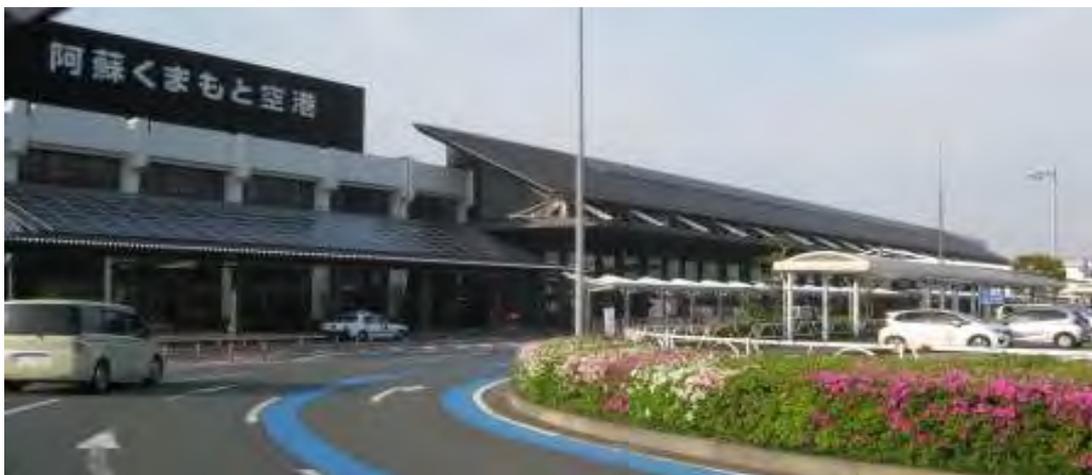
Kumamoto Airport experienced only minor damage to internal fixtures plus minor cracking in interior concrete shear walls. The airport re-opened gradually with flights starting on Tuesday three days following the earthquake sequence.

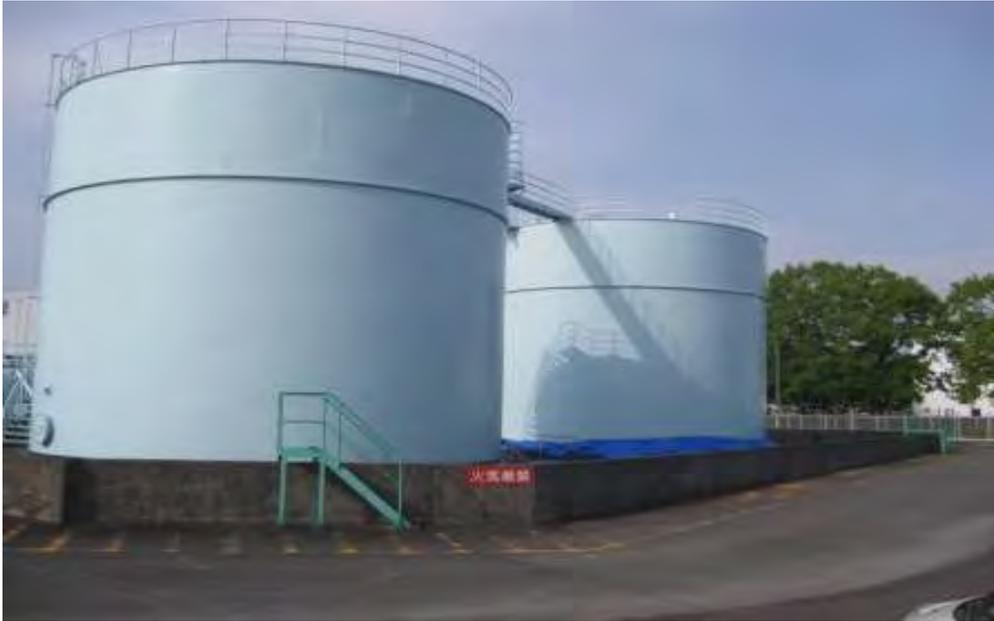
The aviation fuel facility serving Kumamoto Airport stores fuel in two welded unanchored steel tanks of about 300,000 gallons capacity each. Rocking of one tank shattered the asphalt ring around the base for water drainage, but the tanks were otherwise undamaged and able to provide fuel as the airport re-opened.

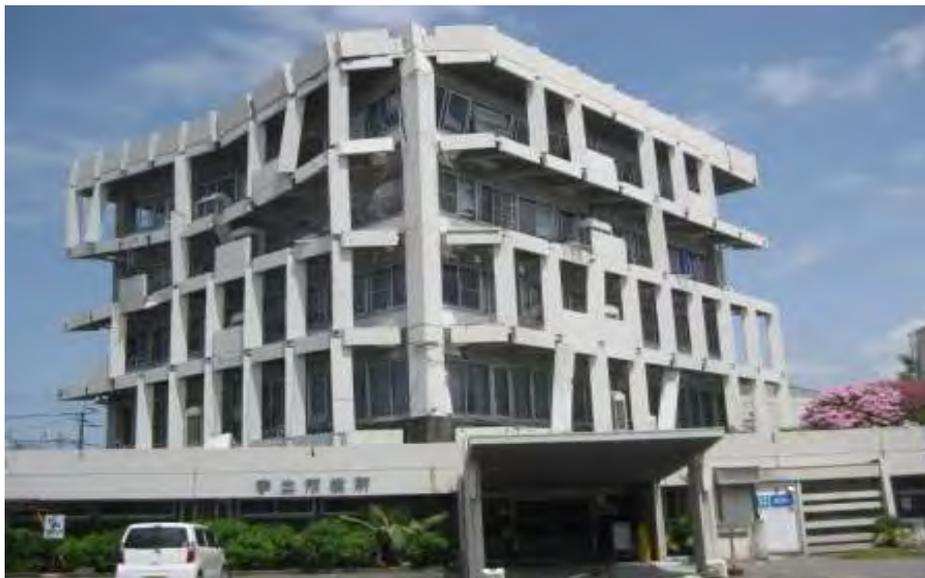
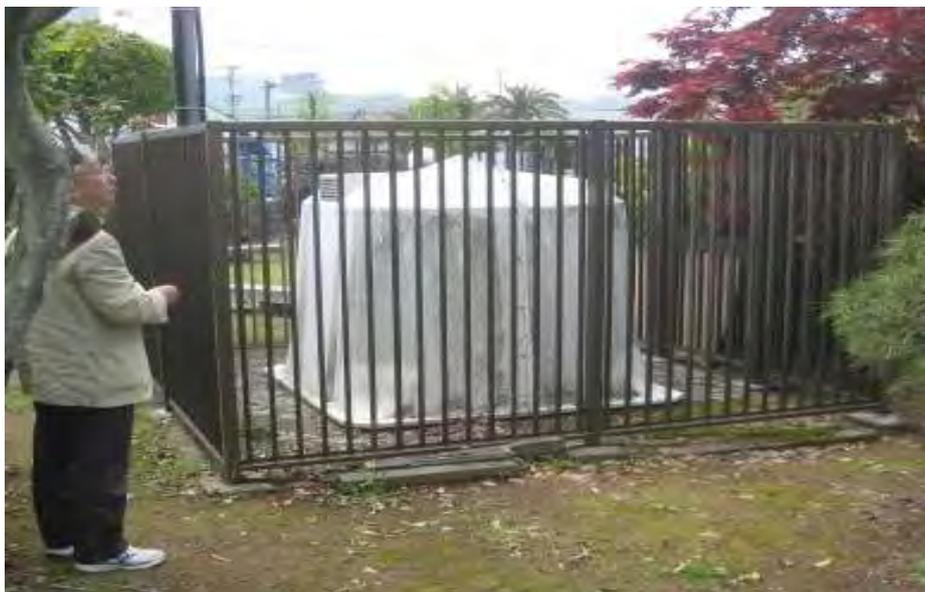
The most serious damage in the Uto area was partial collapse of the city hall due to failure in the main concrete columns. The Uto strong motion recorder is housed in a small enclosure on the city hall grounds (lower photo).

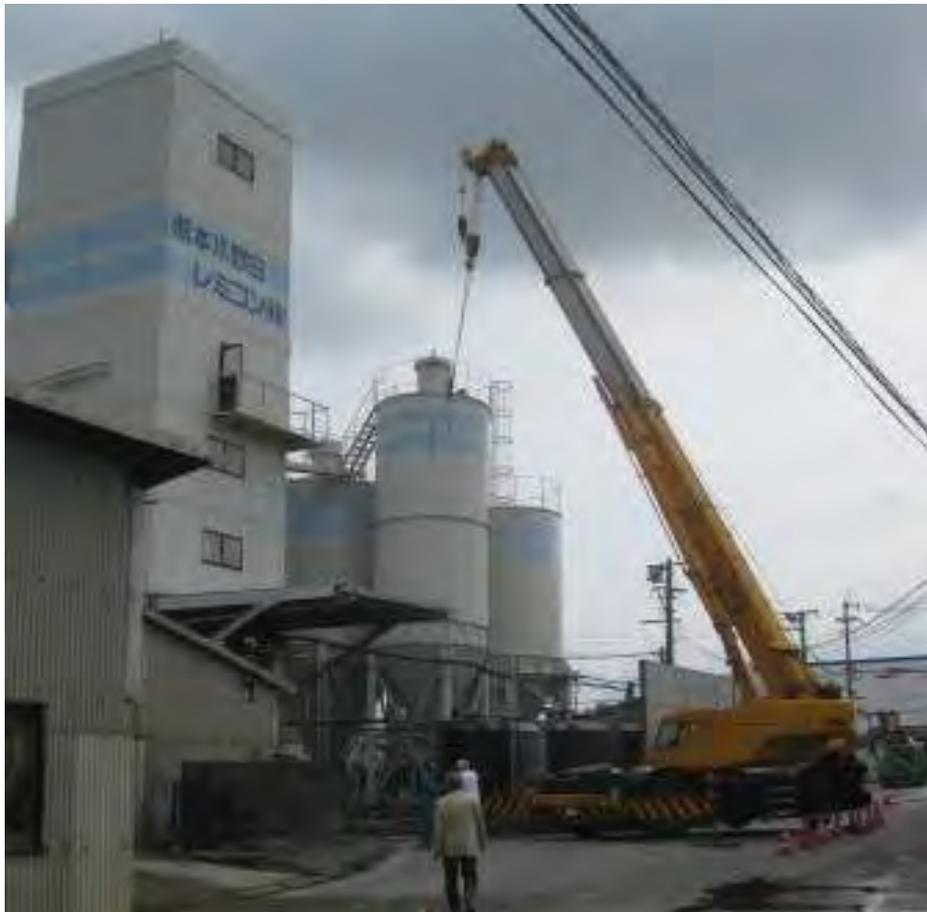
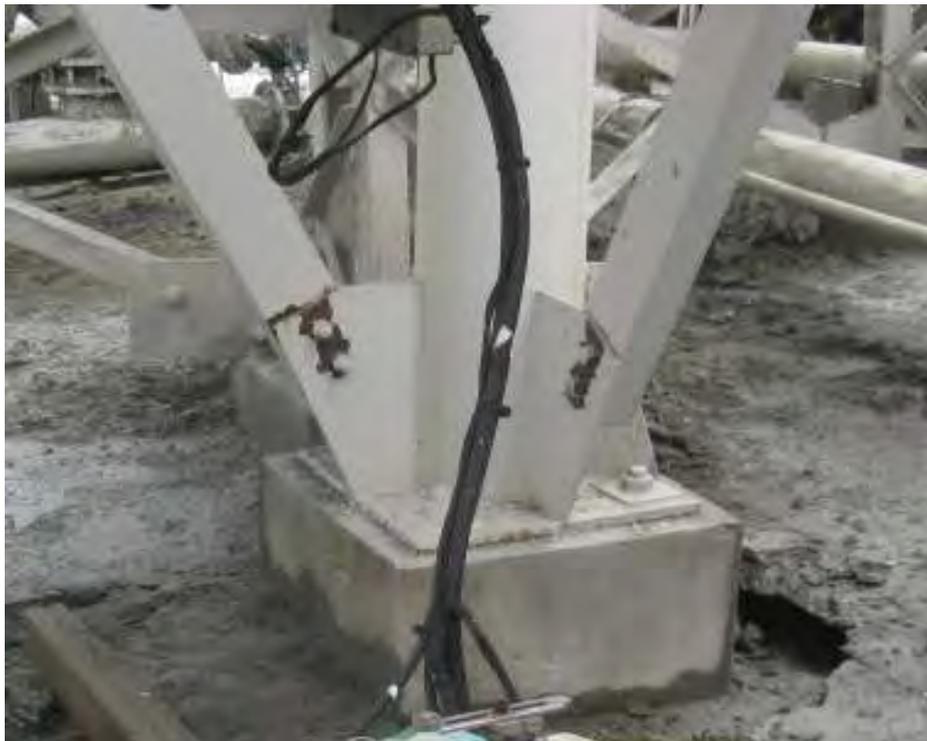
A cement silo at a distribution plant southwest of Kumamoto was being re-levelled by crane lift six days after the earthquake (upper photo). Drop of one corner of the silo foundation pedestal due to soil settlement (lower photo) lifted the opposite corner.

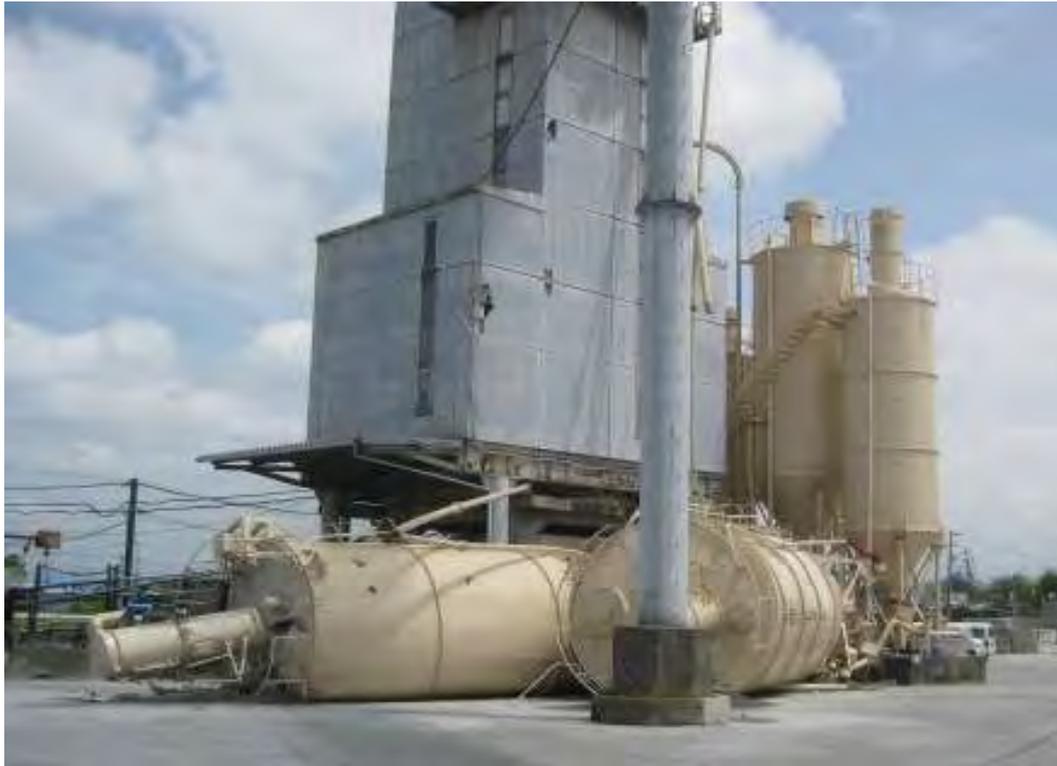
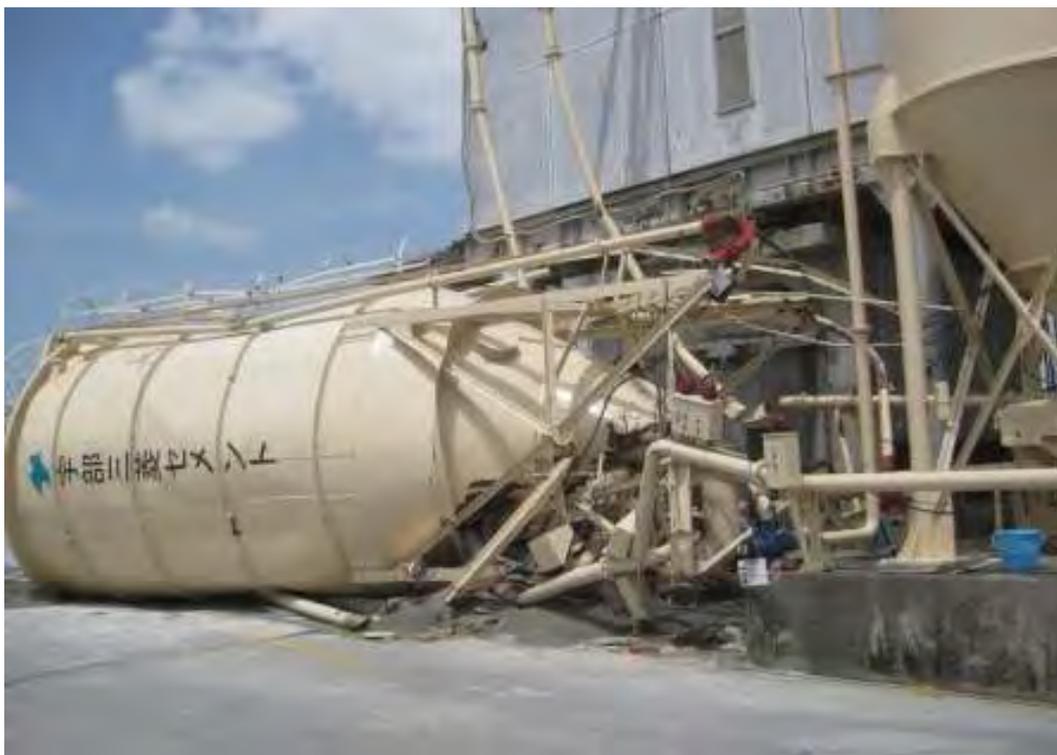
The two larger silos collapsed at a cement distribution plant southeast of Kumamoto. Overturning appeared to be caused by failure at flanged connections in the framing due in part to corroded bolts. The three smaller silos that remained intact and upright were reported as newer installations.

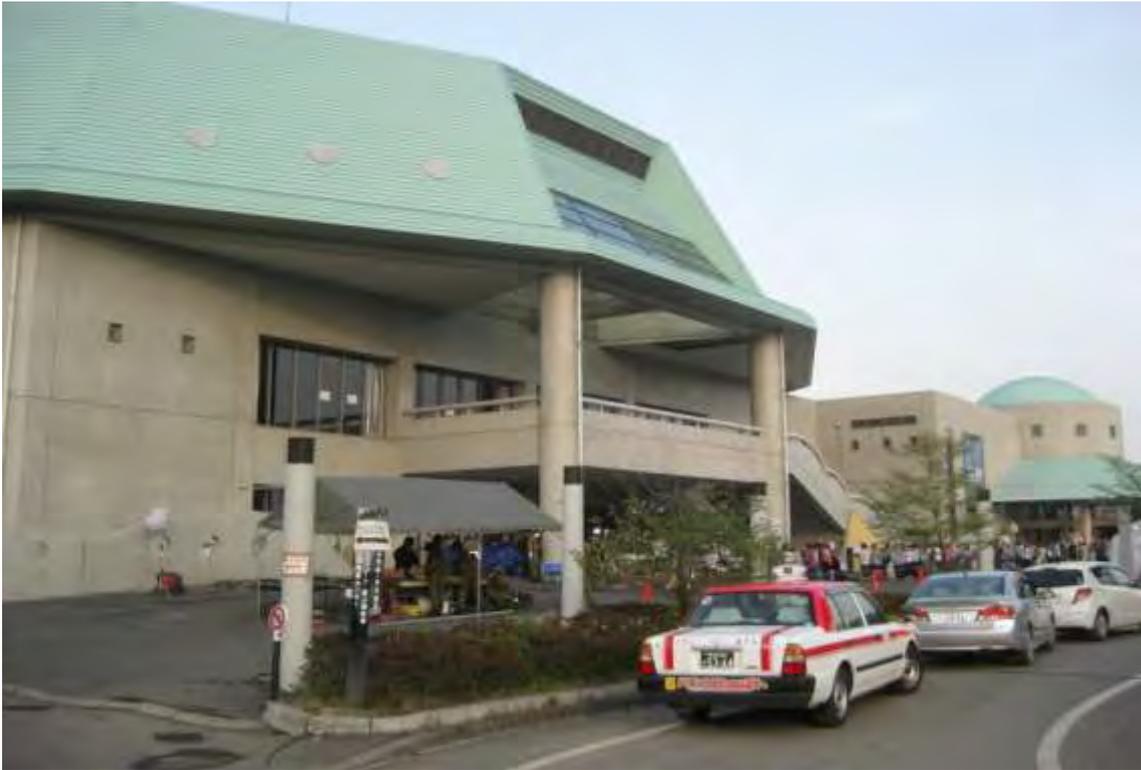
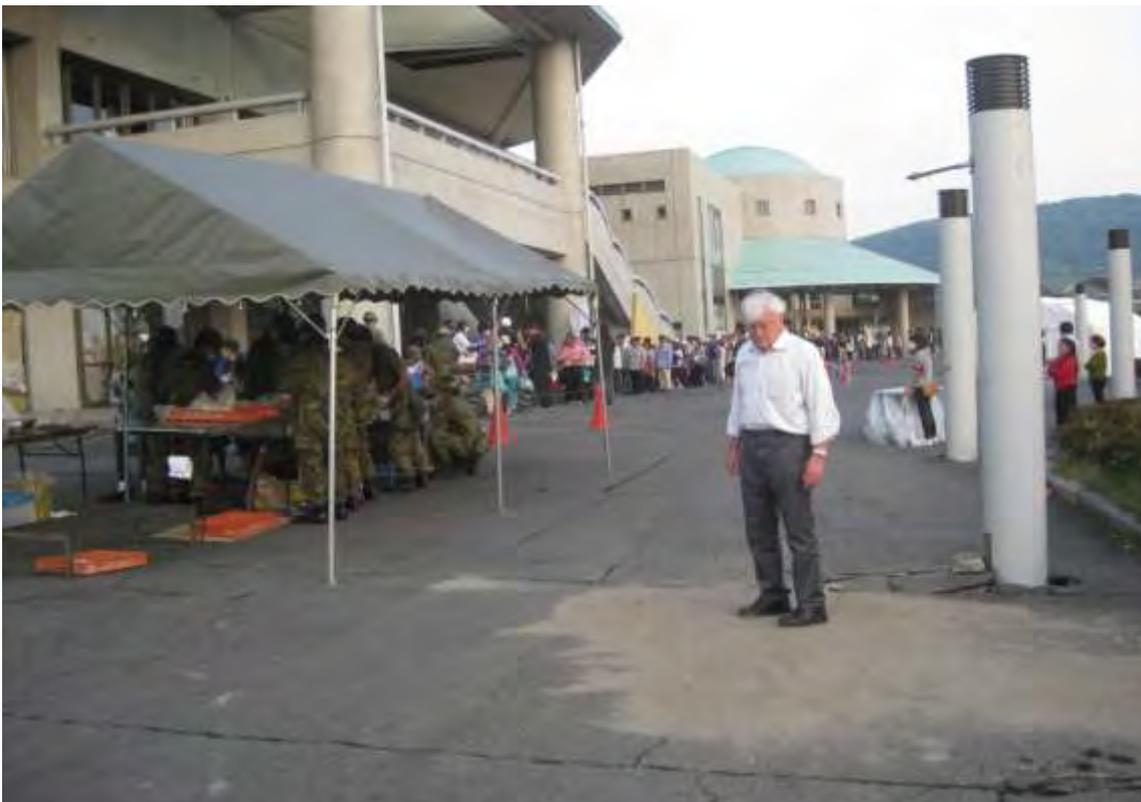
The Mashiki sports complex is a two-storey concrete shear wall structure designated as the emergency shelter and supply distribution point for the most heavily damaged area. The soft soil at the center of the valley displayed severe settlement, creating permanent waves and offsets in the pavement where the local population lined up for supplies. Pockets of liquefaction were indicated by sand boils as shown at lower right in the lower photo.
