The Kumamoto Earthquake Investigation: A Preliminary Report

By
Woody Epstein
Takanao Nishimoto
Koji Okumura
Sam Swan
Peter Yanev

April 29, 2016

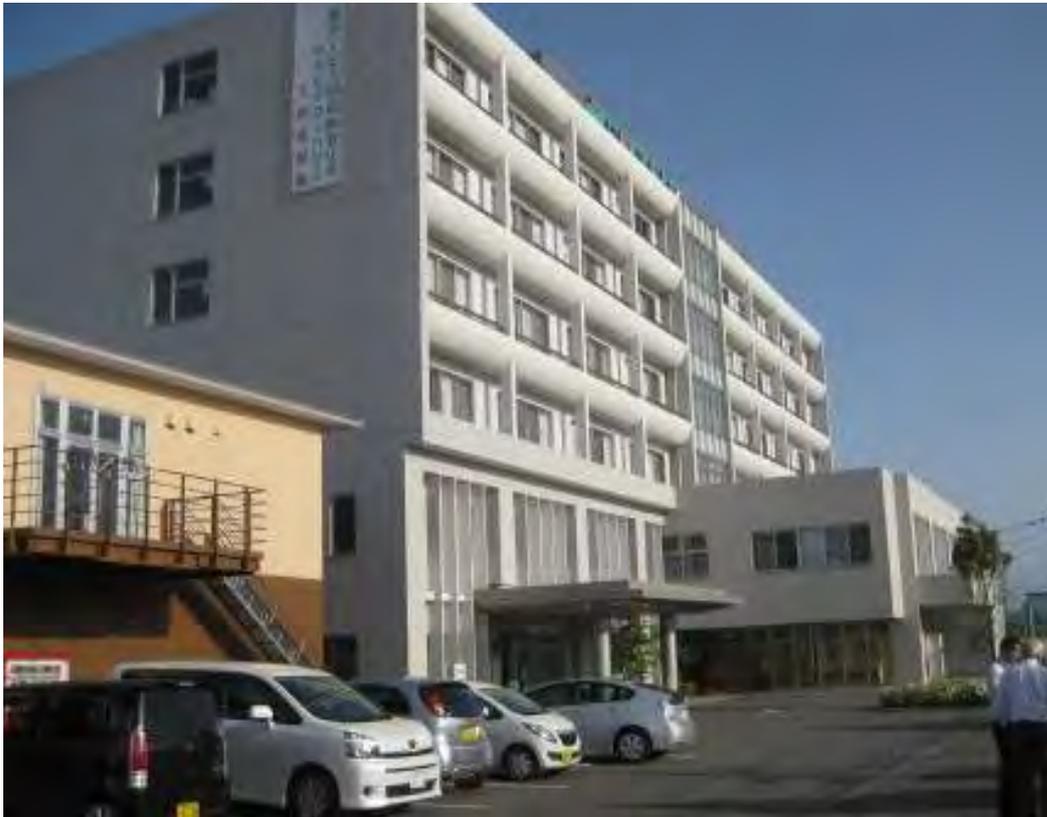
The West Kumamoto Hospital near the town of Uto had essentially no structural damage from the earthquakes despite the apparent high ground motion indicated by the nearby record at the Uto city hall. Operations could be continued immediately following the earthquake due in part to standby power and the on-site water supply.

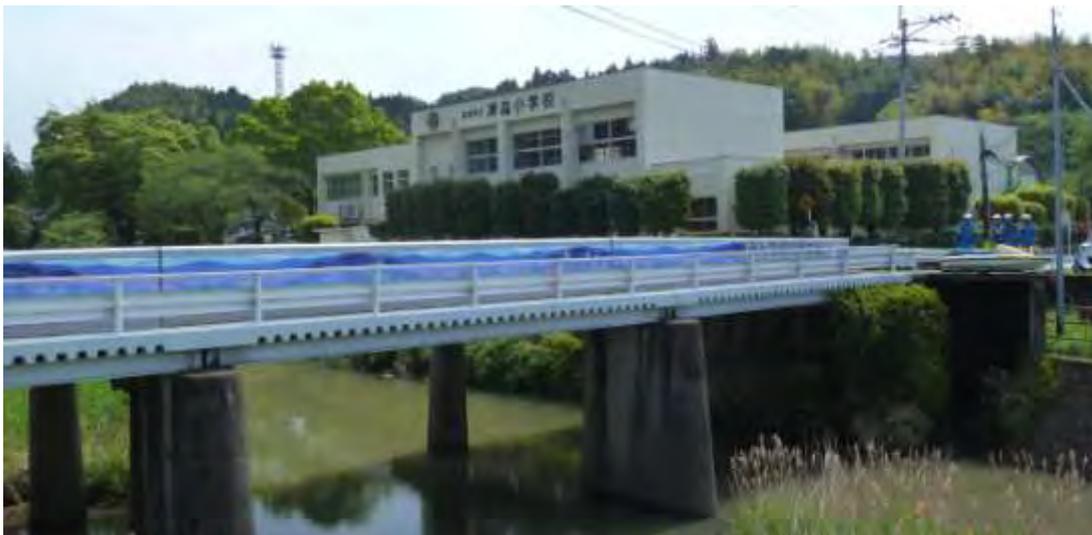
The Tsumori Elementary School in Mashiki, the town most affected by the destructive Kumamoto earthquake. The bridge leading to the school was a major concern for the Principal of the school, as it provides access to the school for many of the students. We did not find any significant damage.

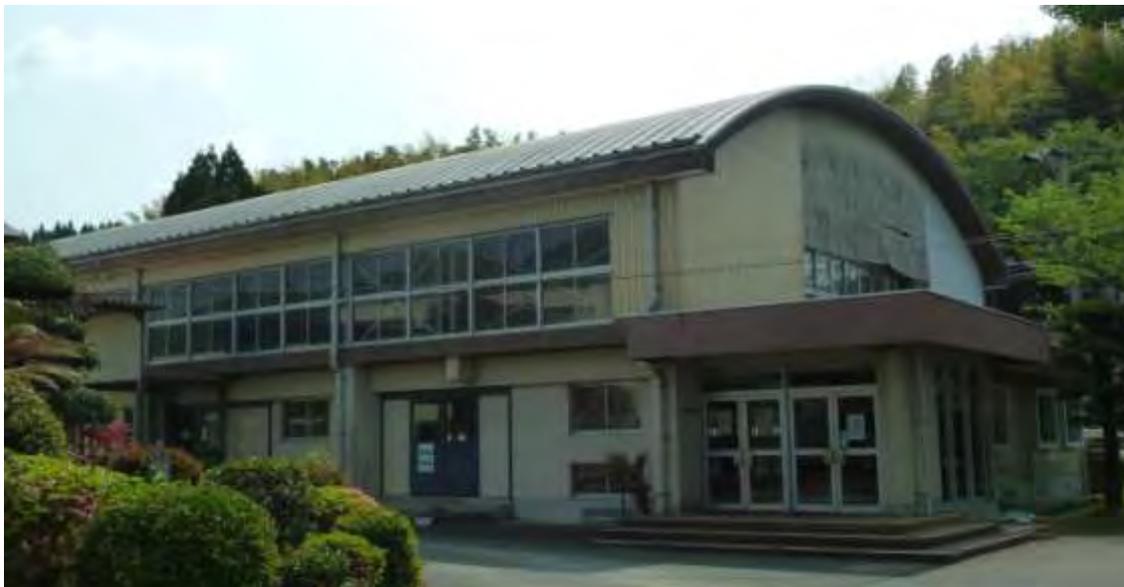
The Tsumori Elementary School gym. One quick look at the building, and adequate familiarity with school earthquake strengthening programs in Japan and around the world, was sufficient for me to realize that this school had been strengthened for earthquakes after it was originally built (well before the more recent earthquake code standards). The steel X-braces (behind the second floor windows and inside the gym) are used often in Japan and elsewhere for strengthening.

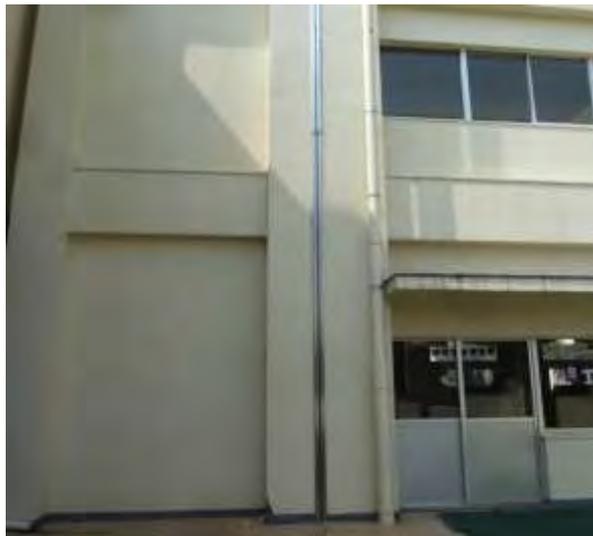
Another obvious strengthening detail - note that the two story solid concrete wall has been added to strengthen the original school. It replaced the windows that were there in the original design. This "shear wall," which adds strength, is a common retrofit detail and works well for this type of concrete-frame construction.

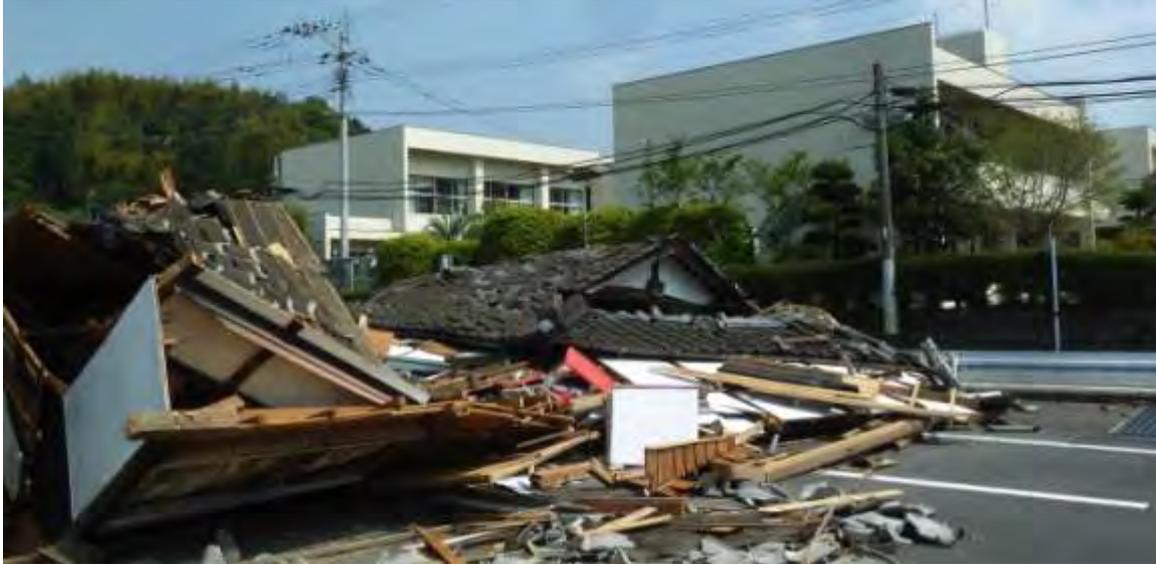
A view of the school from a neighboring house. Contrast the performance of the virtually undamaged school with that of the collapsed house just across the street.

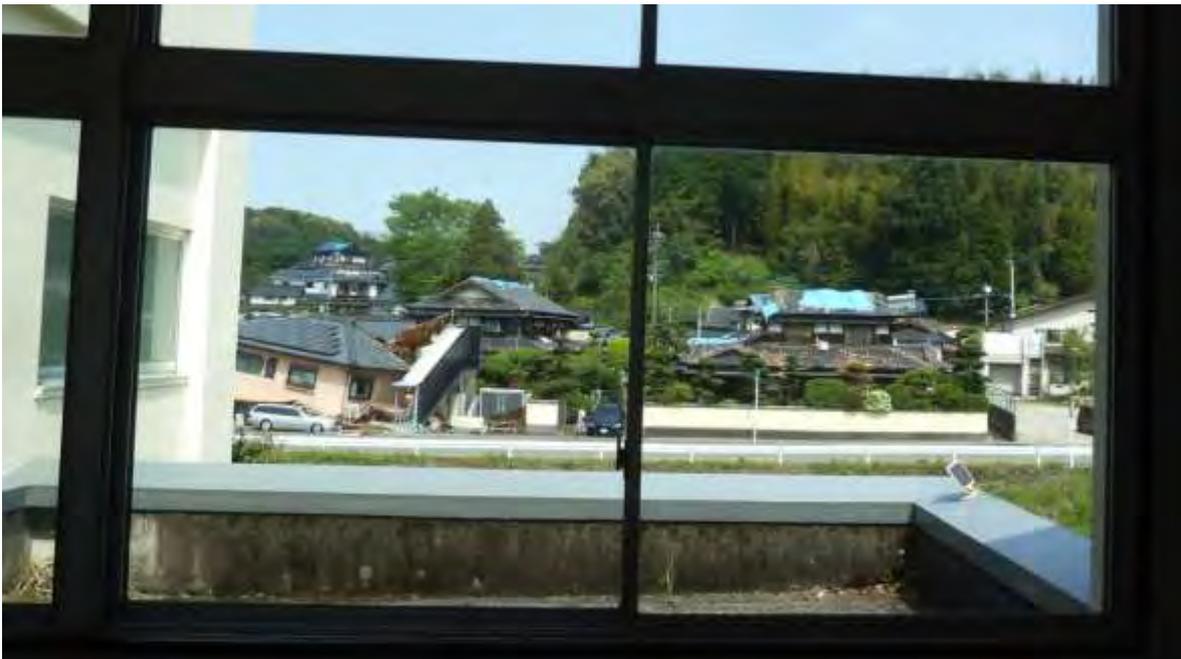
Views of collapsed buildings around the school. The bottom photograph is from inside a classroom, looking at a collapsed small commercial building across the river (also shown in the left photo above).

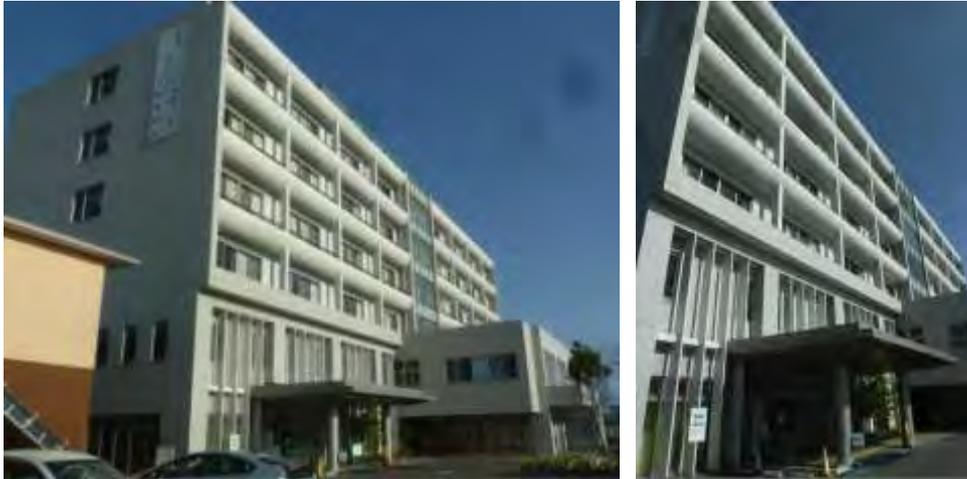
The main building of the hospital, built in 2012 showed no visible structural damage. The only significant damage inside the building was minor spalling at seismic (expansion) joints. There was also minor settlement of the ground (and excavation backfills) around the buildings.

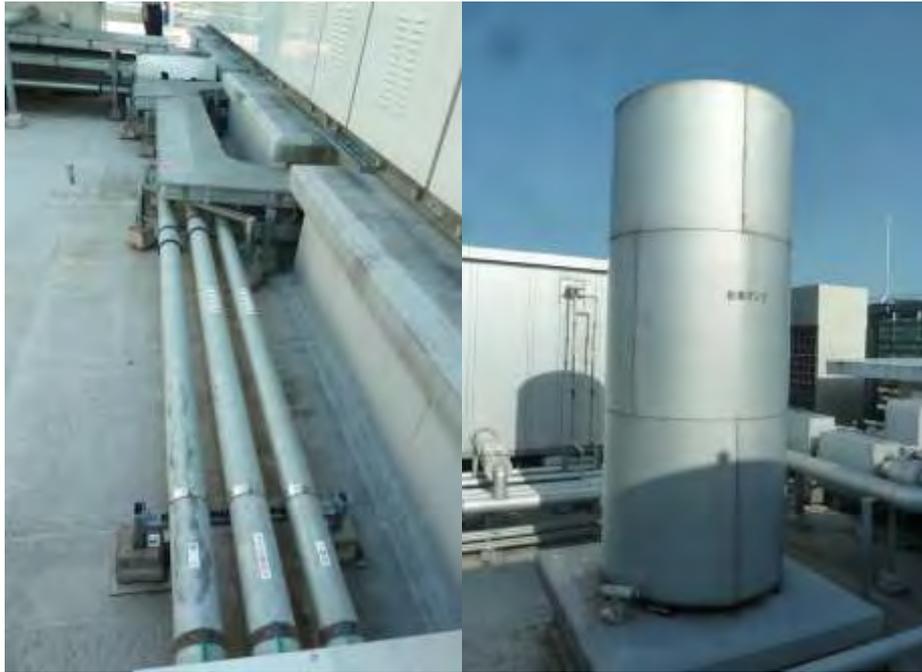
Some of the equipment on the roof of the six-story main building. None of the equipment was damaged in the earthquake. Our inspection revealed good design details for the anchorages and braces of the equipment, piping, and other systems.

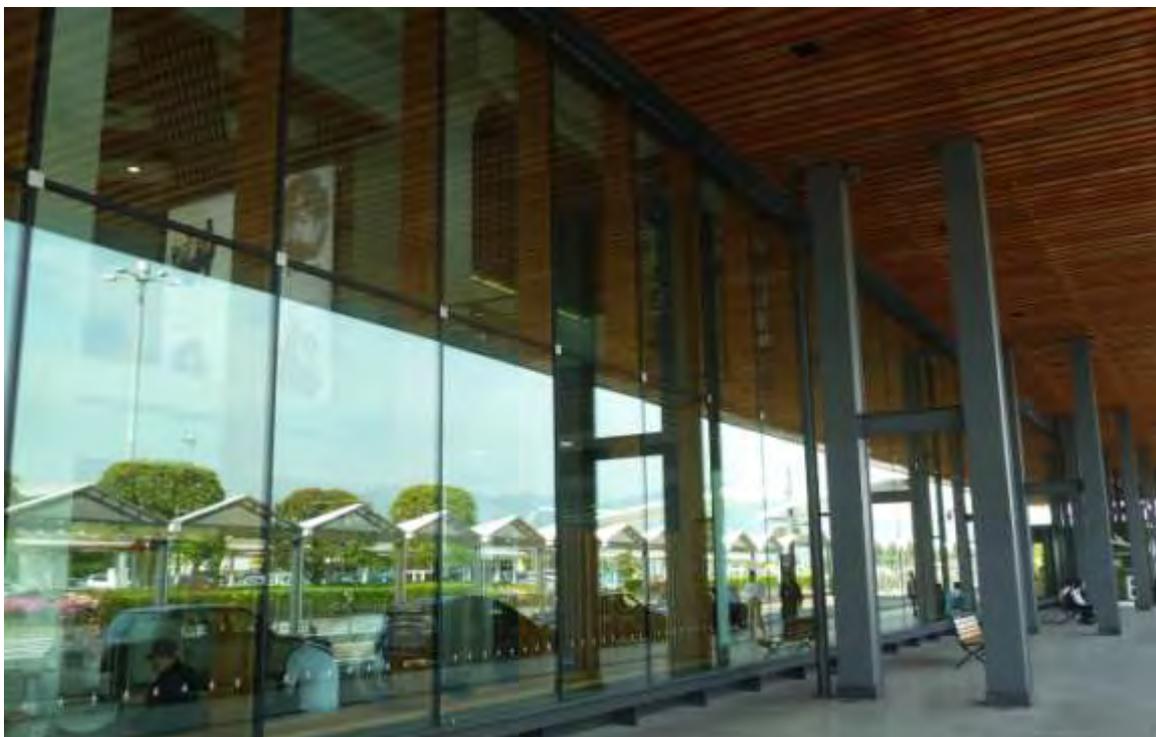
A notable success at the new terminal was the performance of the glazing. We found no damage to these large glass panels. Given the strength of the shaking at the airport, the design details for the glazing should be studied in further detail. Details such as these are difficult for engineers to analyze. Further, they are difficult to test on shake tables. Post-earthquake experience data, such as what we collected at the Kumamoto Airport, are valuable for future designs as well as for the development of adequate and not overly conservative building code requirements for architectural and equipment details.

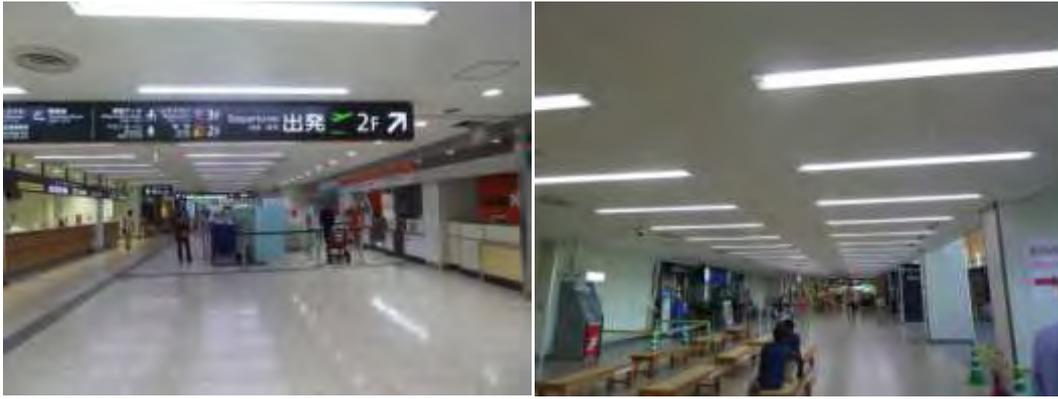
The rigid suspended ceilings throughout the new terminal performed well. We did not notice any significant damage. There was minor damage at interfaces with columns and walls. In the past, damage to flexible suspended ceilings at airports has been a major cause of service interruptions.

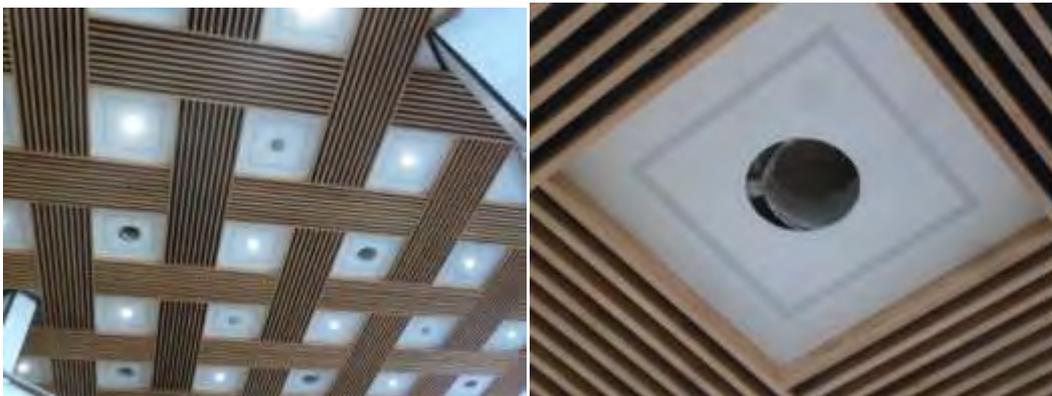
The most life-threatening damage that we observed at the new terminal was the falling of inadequately anchored or braced light fixtures. Note the missing fixture in the right photo. Many of these fixtures had fallen. The ceilings around the failed fixtures are undamaged.

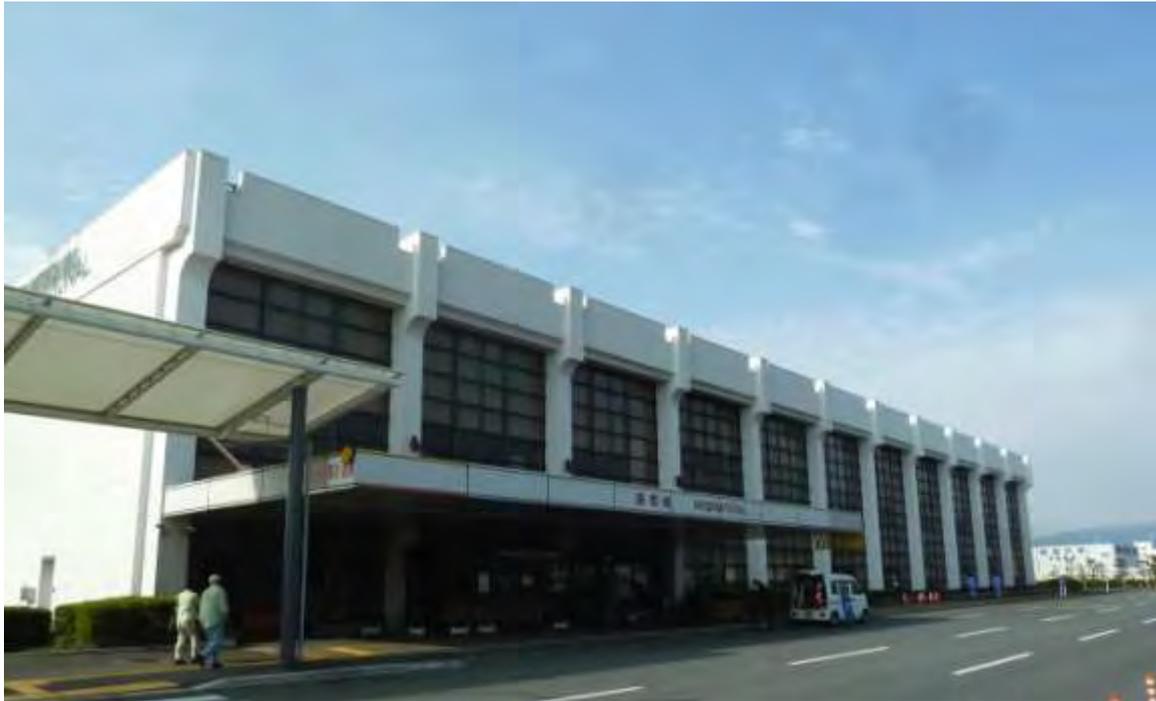
The old reinforced concrete International Terminal, built in the late 1960s, was closed at the time of our investigation due to reported structural damage. We could not observe the damage from the outside, but given the vintage of the structure and the outdated and inadequate code to which it was designed, plus the strength of the ground shaking, serious structural damage should have been expected unless the structure had been strengthened more recently. This type of structure is a classic example of a high-risk structure that often requires strengthening for life-safety and for the reduction of business interruptions.
