The Kumamoto Earthquake Investigation: A Preliminary Report

By
Woody Epstein
Takanao Nishimoto
Koji Okumura
Sam Swan
Peter Yanev

April 29, 2016

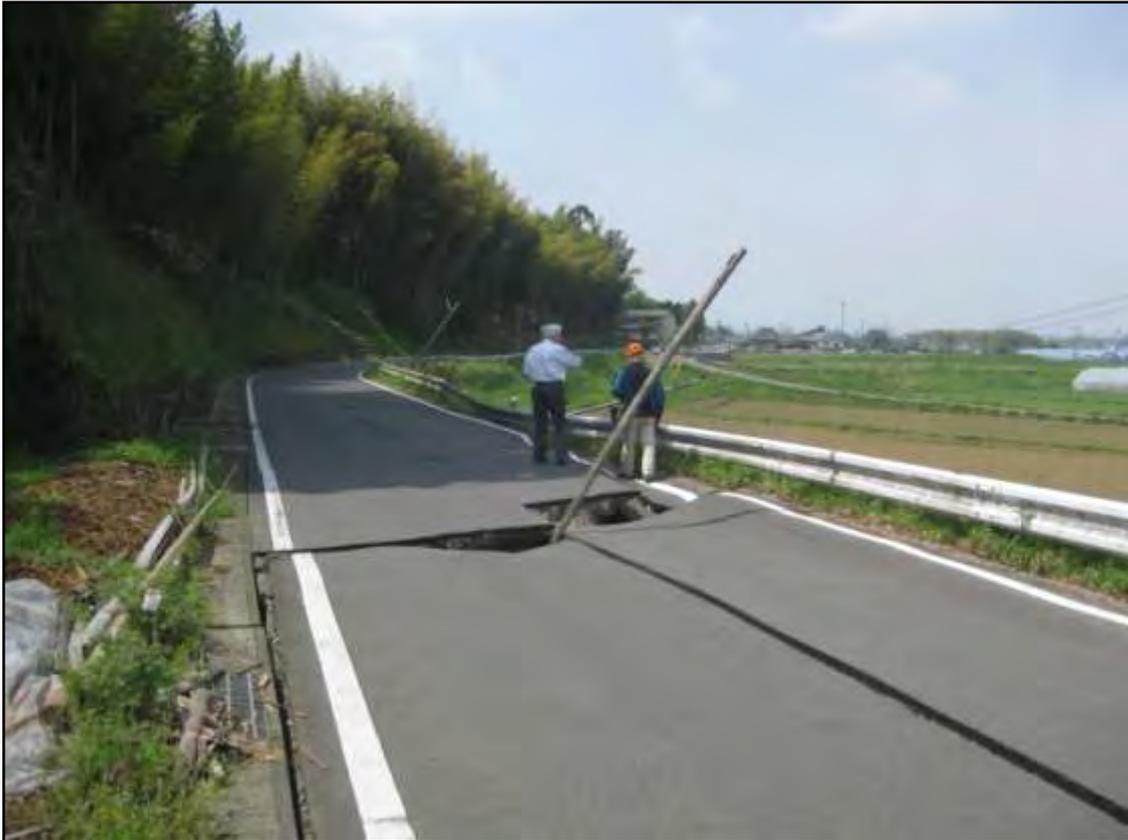
The fault rupturing the surface on a road in Mashiki Town

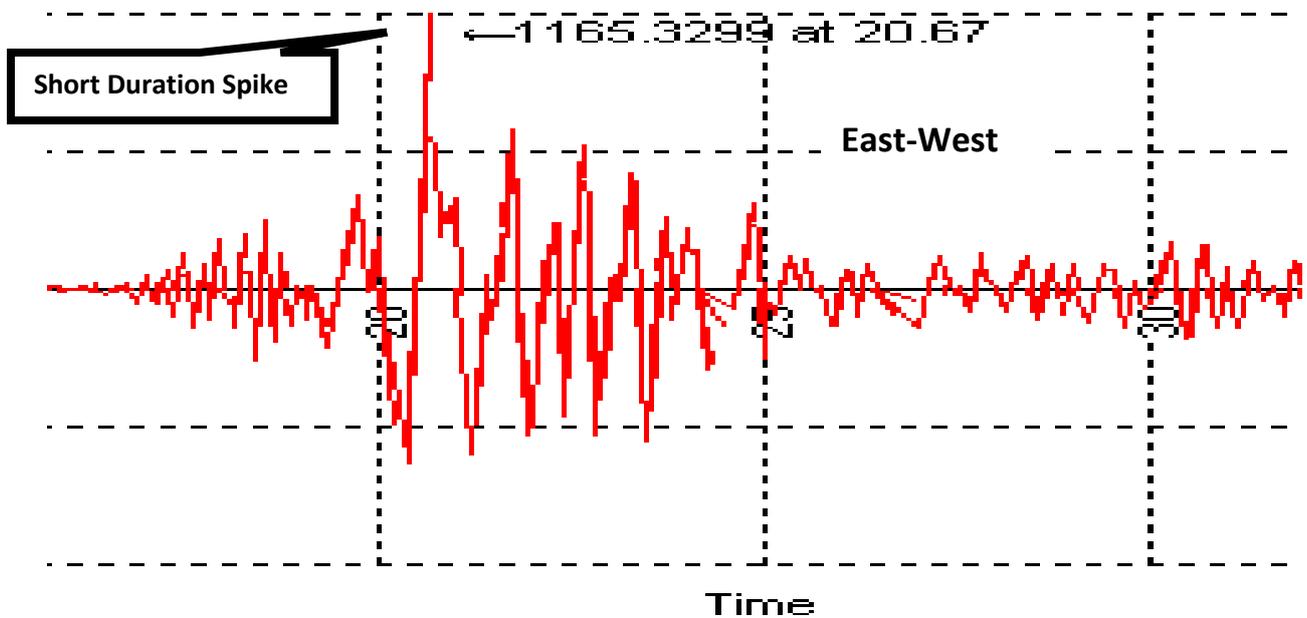
KMMH16 Mashiki (04/16/16 01:21 JST)

The strong motion record above the heavily damaged Mashiki residential area recorded over 1.0g in the east-west direction. This peak ground acceleration however is observed from the acceleration time history as a short duration spike. The amplitude exceeds the more realistic measured acceleration of about 0.50g for less than 0.1 second. This short duration of peak acceleration would have minimal energy content and hence a minor contribution to damage in the area.

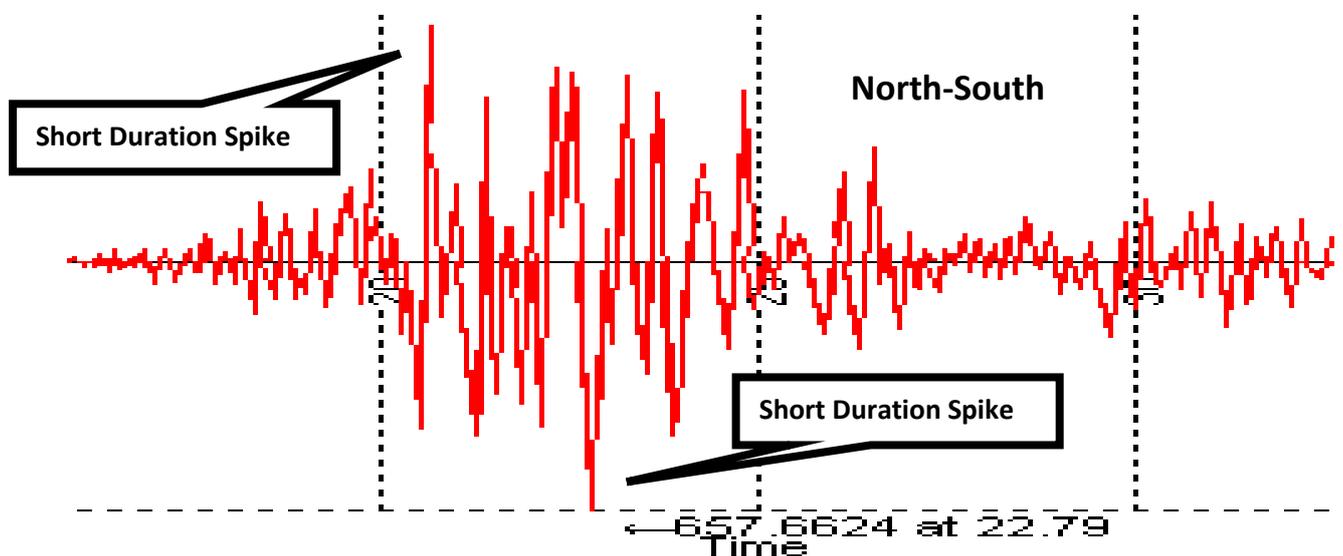
KMMH16 Mashiki (04/16/16 01:21 JST)

The peak ground accelerations recorded by the Mashiki strong motion instrument are spikes in the measured horizontal acceleration, with durations of less than 0.1 second, lacking serious energy content compared to the longer duration acceleration cycles of less amplitude.

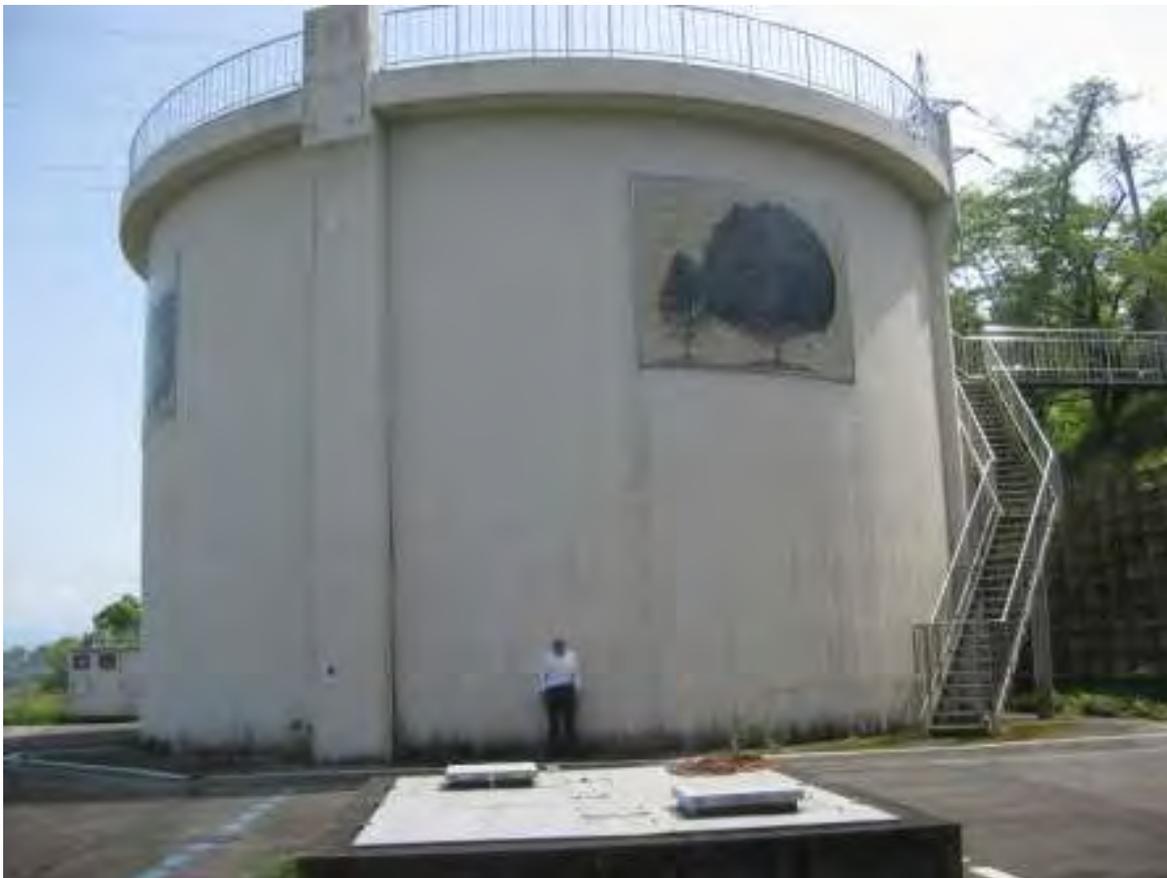
As the heavily shaken area was visited in the immediate days following the earthquake, water was noticed leaking into streets from broken mains in the heavily damaged area of Mashiki. Repair of failed water lines requires first location of the break, isolating the damaged section of line, excavation, line repair, re-pressurizing the line to ensure the leak is repaired, then replacement of surface covering. Water service was initially lost to over 400,000 customers in the Kumamoto region (*Japan Times*). After bypassing damaged pipelines, service had been restored to all but about 90,000 customers by Tuesday three days after the earthquake. Restoration of water service to the heavily damaged area in the Mashiki Valley was likely to take more than a week.

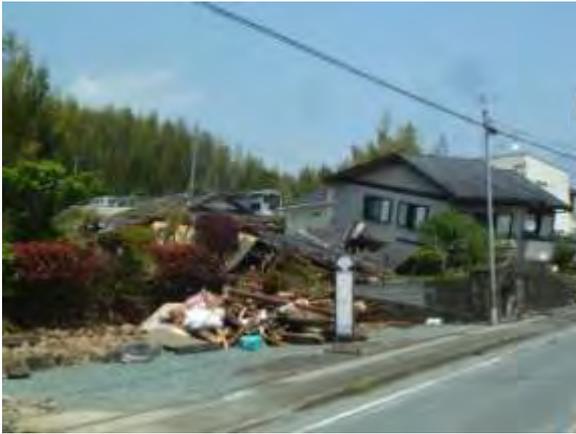
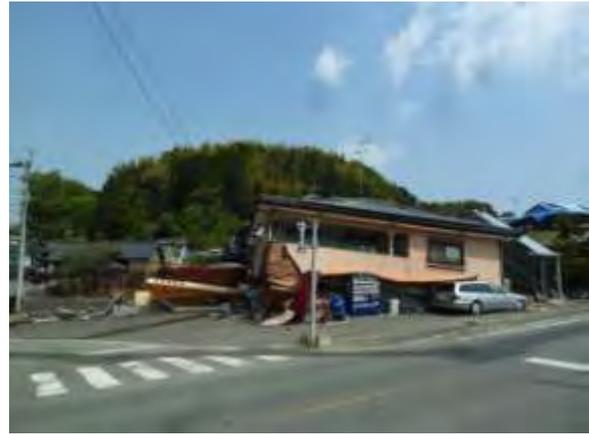
Views of collapsed buildings around the school. The bottom photograph is from inside a classroom, looking at a collapsed small commercial building across the river (also shown in the left photo above).

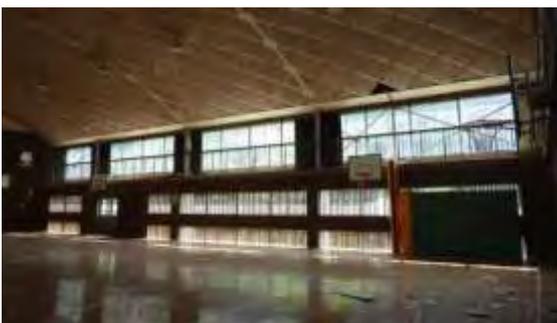
Interior of the virtually undamaged gym. A few lightweight ceiling tiles fell because of inadequate attachment to the structural roof (and ceiling). The debris can be seen in the lower right corner; all the windows are intact.

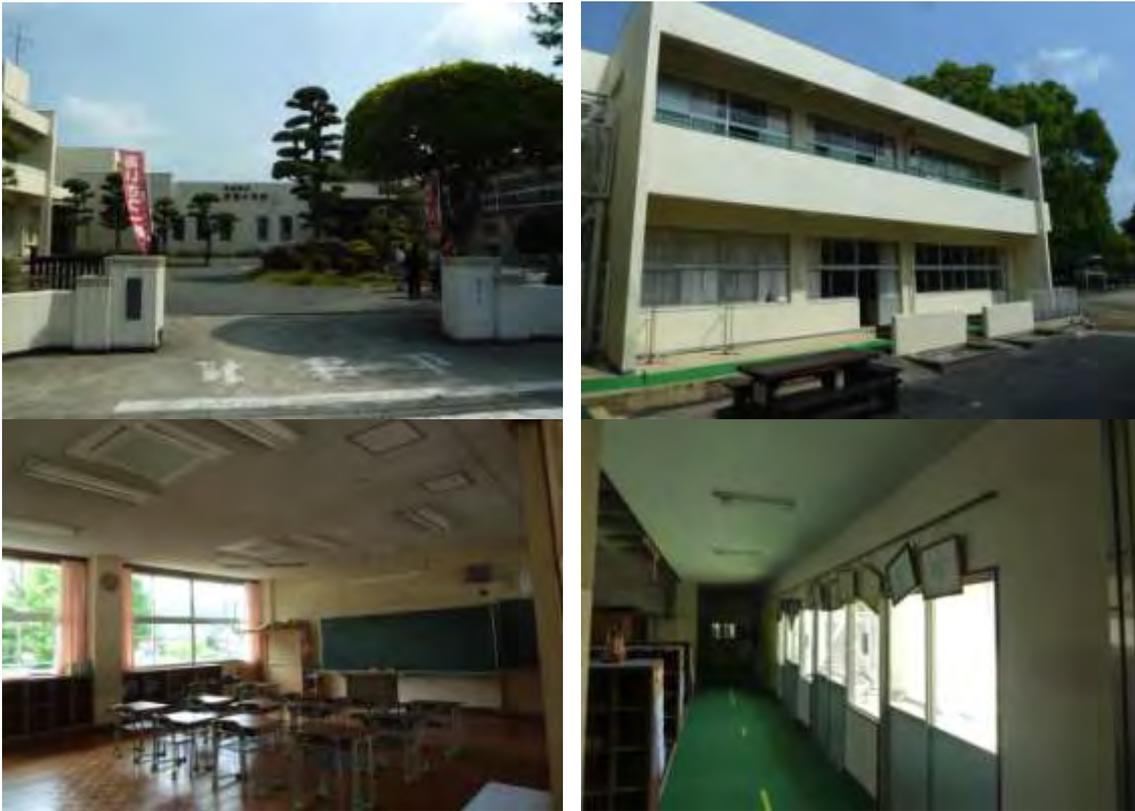
Additional photos of the practically undamaged interior and exterior of the elementary school.

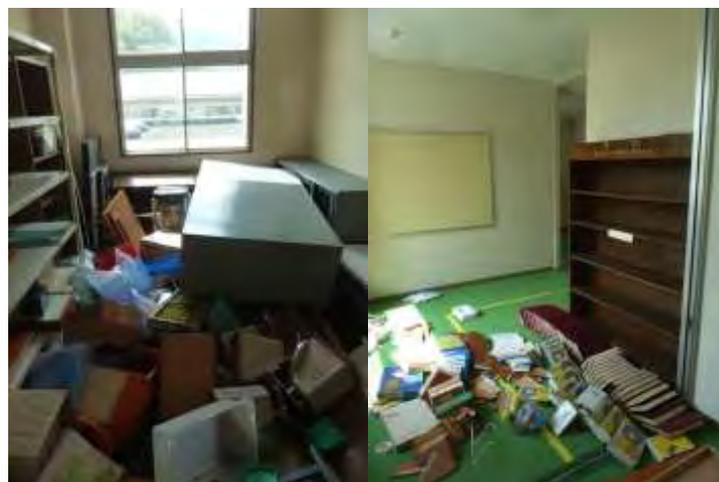
A fallen office cabinet (that was not anchored or braced) and books in a hall that had not been cleaned up at the time of our visit. As the earthquake occurred at night, the school was not occupied and no injuries occurred.

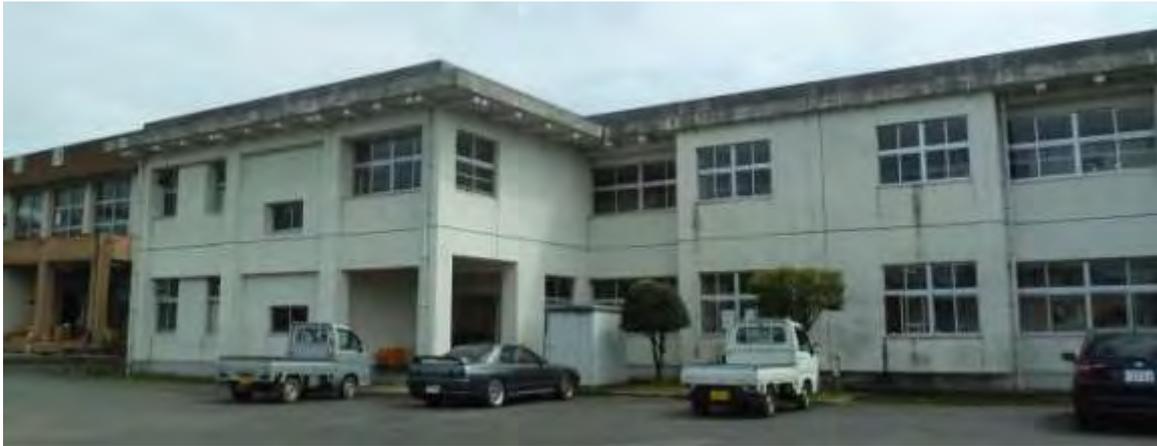
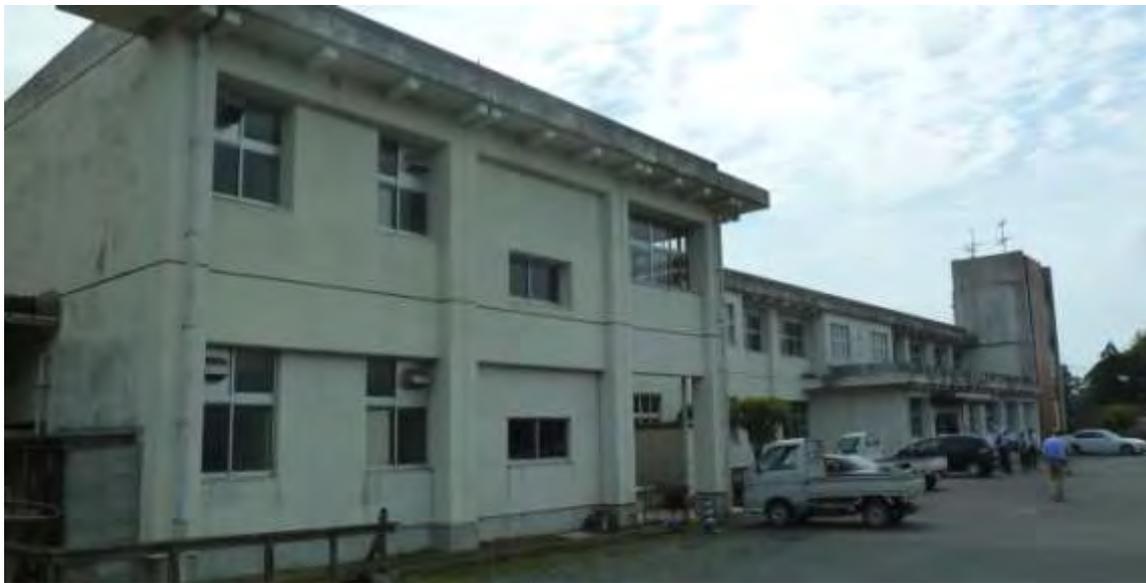
Another essentially undamaged older school in the earthquake area. Again, note the additional “shear walls” that were added, blocking some of the pre-existing windows. Because of the declining student population, the school is no longer used for teaching. Fortunately, the buildings are now available as emergency shelters for those that lost their homes in the earthquake. Other than life safety for students, one of the primary additional reasons for focusing on strengthening schools is their potential use as emergency shelters following disasters.

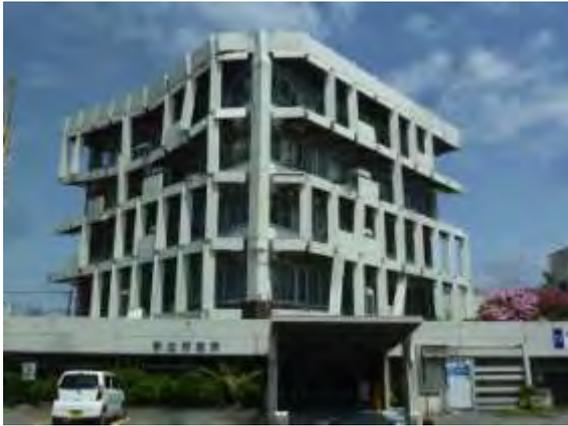
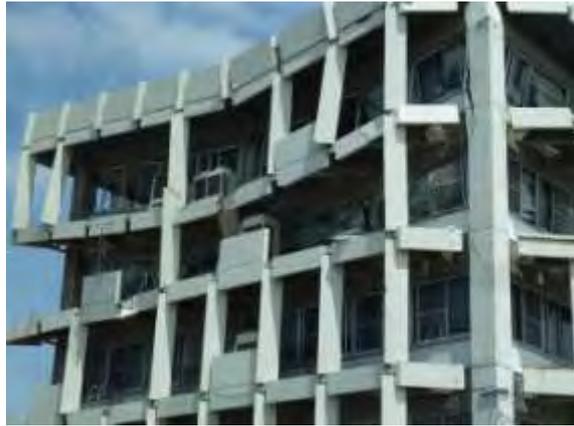
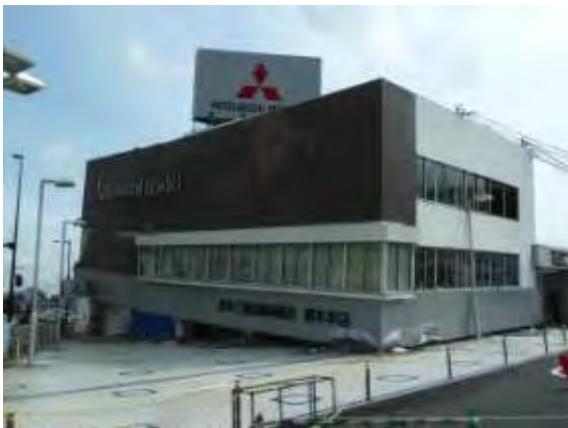
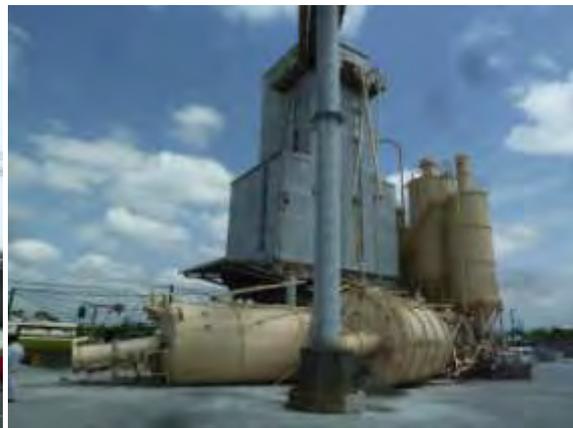
Two heavily damaged reinforced concrete buildings in the general region of the hospital, which is roughly equidistant from the two buildings. Both of these buildings are much older and are designed to outdated and, obviously, deficient building codes. The building on top is Uto City Hall. The visible façade damage is due to the failure of precast concrete non-structural façade panels (shown in more detail on the right). The main concrete frame of the building is heavily damaged and near collapse. The recorded ground motions, shown in the previous illustrations, were made on the City Hall site, outside the building. The second two-story building (lower left) had an inadequate soft-story ground floor that collapsed. The photo on the lower right shows collapsed silos at a nearby concrete batch plant (Kumamoto Ryoko Concrete Co.). Two of five silos collapsed. The three newer silos, in the back, designed to higher and more recent design criteria survived without significant damage.

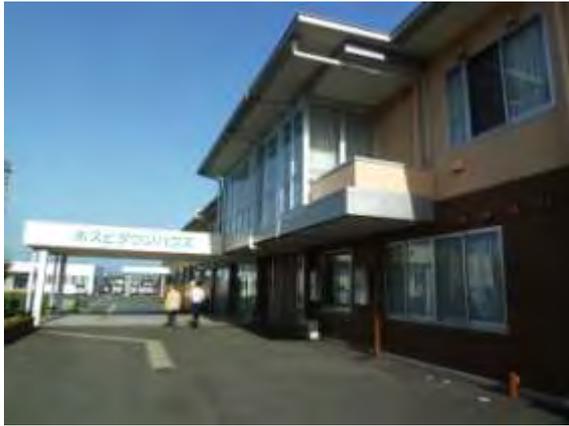
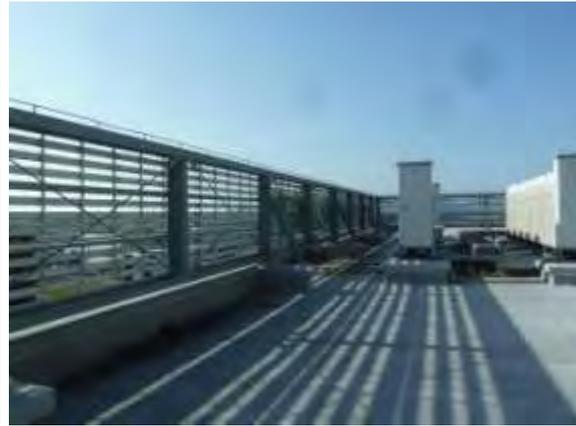
The hospital buildings suffered no significant or visible structural damage. The six-story main building is a 3-year-old shear-wall concrete structure, completed in 2012. The two-story adjacent hospital building was completed in 1989. The ground around the two buildings compacted and settled a little during the earthquake, causing no damage to the structures. The only damage noted on the interior ground floor was minor damage at structural expansion joints (gaps), which were specifically designed to allow adjacent parts of the structures to move and which are expected to suffer minor damage, similar to what happened.

partial view of one of the two story hospital buildings (left) and the undamaged steel framed and braced parapet on the roof of the 6-story main building.

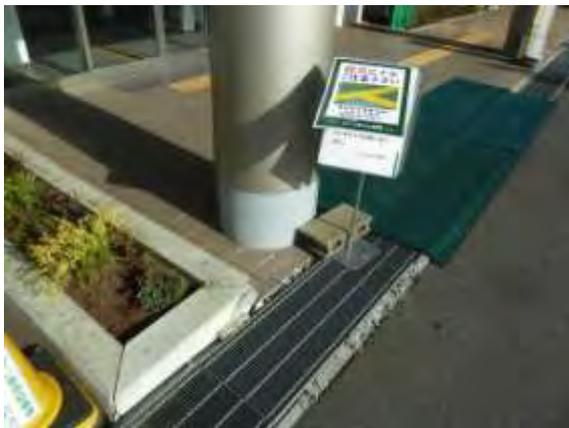
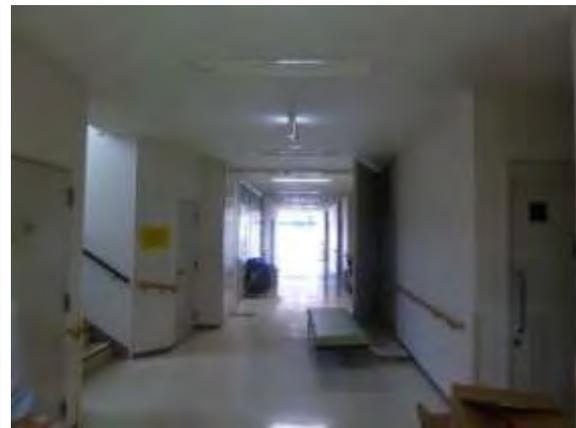
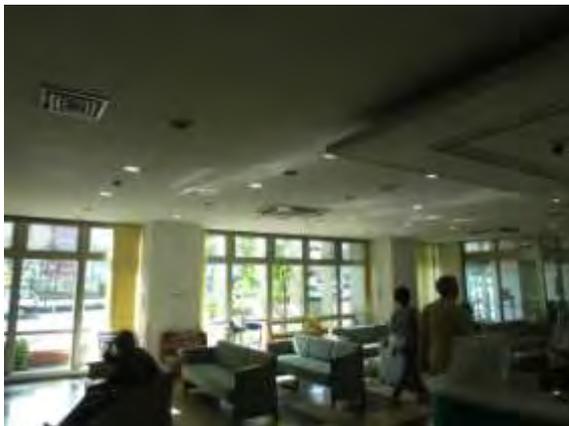
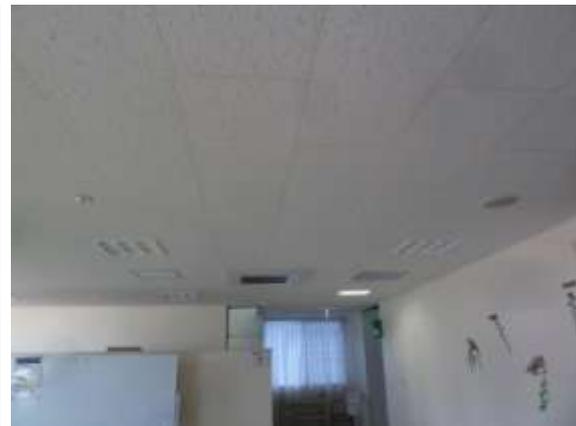
The most obvious, and inconsequential damage to the hospital was minor settlement around the periphery of buildings. The photo in the upper right shows some settlement at the main entrance to the hospital. The other three photos are of interiors of the main building, including the lobby (lower left). Note that the undamaged ceilings are rigid ceilings and not flexible, suspended ceilings that are typically easily damaged.

The hospital engineer stated that the earthquake caused only minor and insignificant damage to the interior of the hospital, including minor damage to ceilings. We noted that the hospital did not have suspended ceilings anywhere in the areas visited. That is likely a primary reason why the interior performed as well as it did.

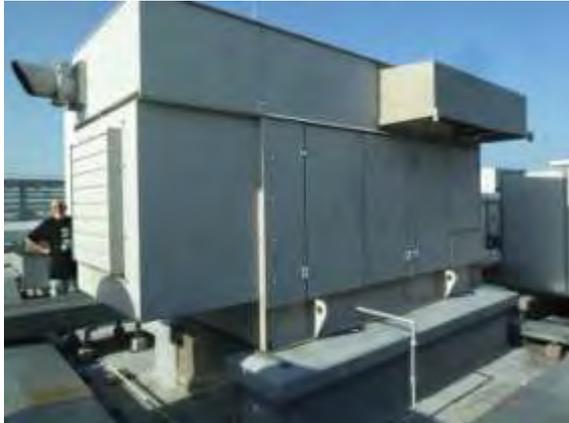
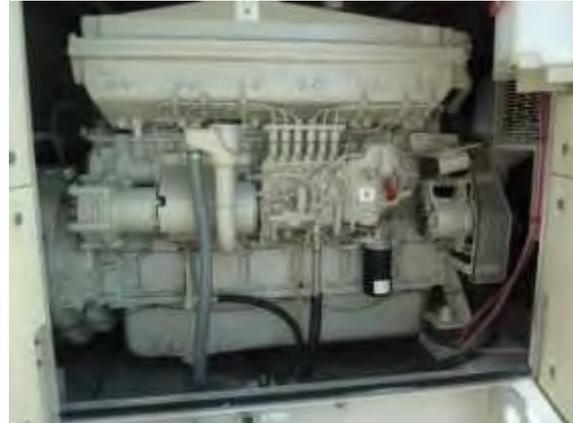
The emergency diesel, located on the roof of the six-story main building, started up upon loss of off-site power. That, and a second generator in one of the other buildings, provided adequate power to the hospital following the earthquake, until off-site power was restored.

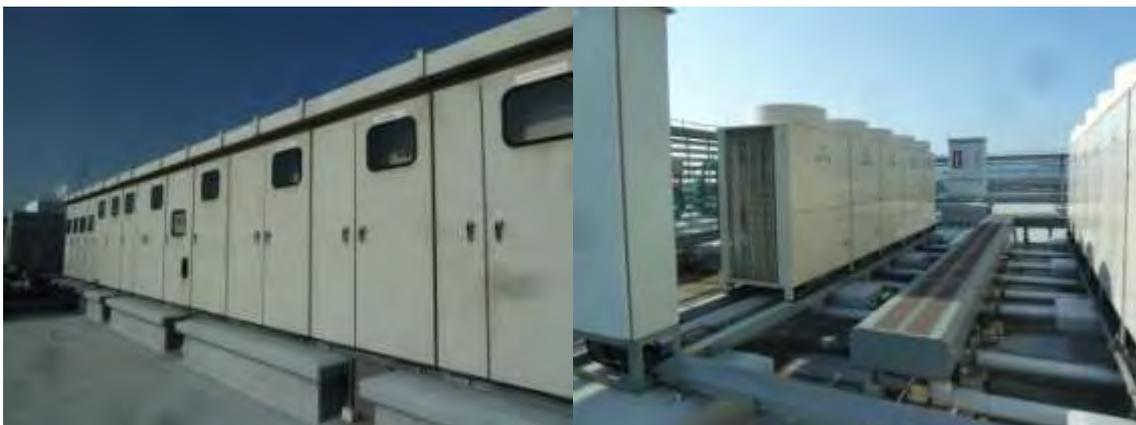
Much of the critical mechanical and electrical equipment of the hospital is on the roof. Some of that equipment is shown in the photographs below. All of the equipment on the roof is bolted or braced; none was damaged. We observed that the bolting and bracing details for the equipment were designed to standard industrial details, not to the much more stringent and expensive details required of hospitals in California, for example.

Some of the equipment on the roof of the six-story main building. None of the equipment was damaged in the earthquake. Our inspection revealed good design details for the anchorages and braces of the equipment, piping, and other systems.

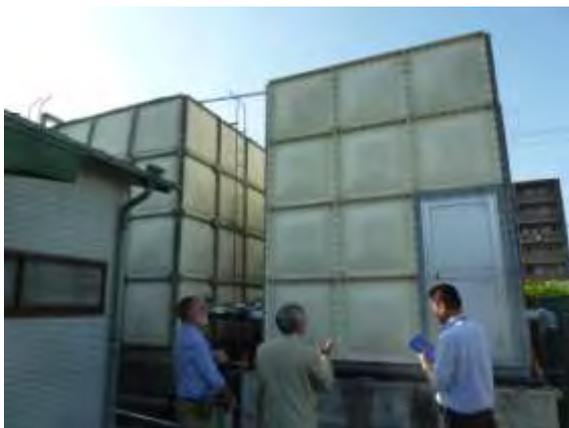
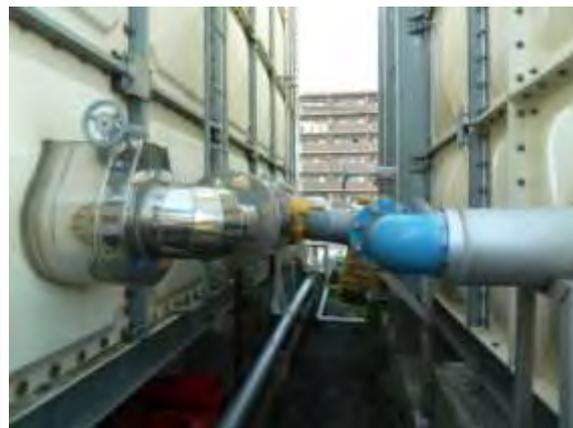
Potable and service water for the hospital is stored in five (or more) tanks at ground level outside the hospital buildings. The tanks were not damaged. Two of the tanks lost water when piping interconnecting the tanks broke due to differential movements of the tanks during the earthquake. The pipes connecting the tanks did not have flexible joints but were rigid and could not accommodate the differential movement. The partial loss of inventory did not affect significantly hospital operations. The broken pipes were repaired quickly.

Two anchored potable water tanks lost contents when the rigid piping that interconnected them failed due to differential tank movement during the earthquake. The repaired lines are shown on the right. A flexible pipe connection between them would have prevented the only significant equipment and systems damage at the hospital.

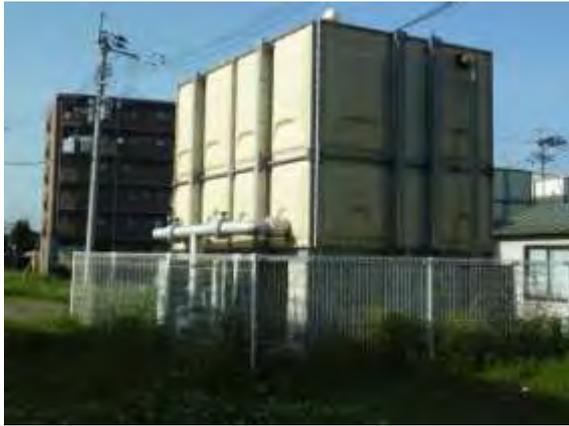
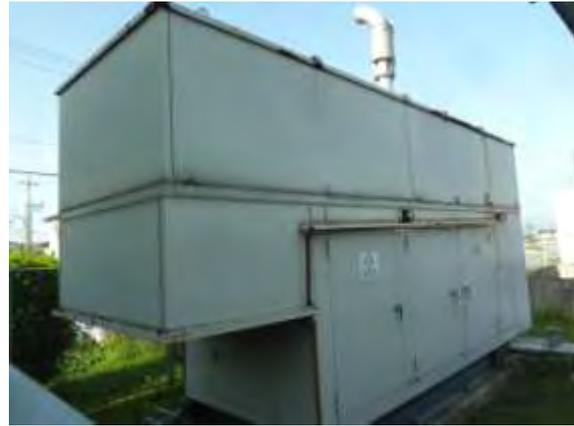
Other anchored equipment at ground level had no damage, including the two potable water tanks on the left and a diesel generator on the right.

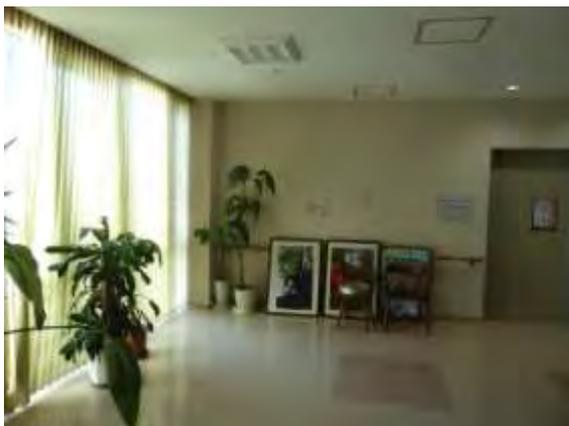
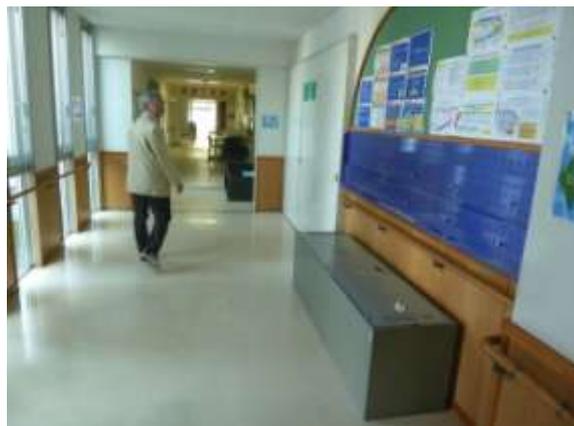
Out of concern for further aftershocks, the hospital placed art and other wall mounted objects on the floor (left). Heavy furniture that can overturn, such as the tall cabinet on the right, were also lowered to the floor so that they would not tip over in aftershocks. I have visited many hospitals, and other public buildings along the Pacific West Coast and throughout the world after earthquakes – this thoughtful precaution was a first for me.

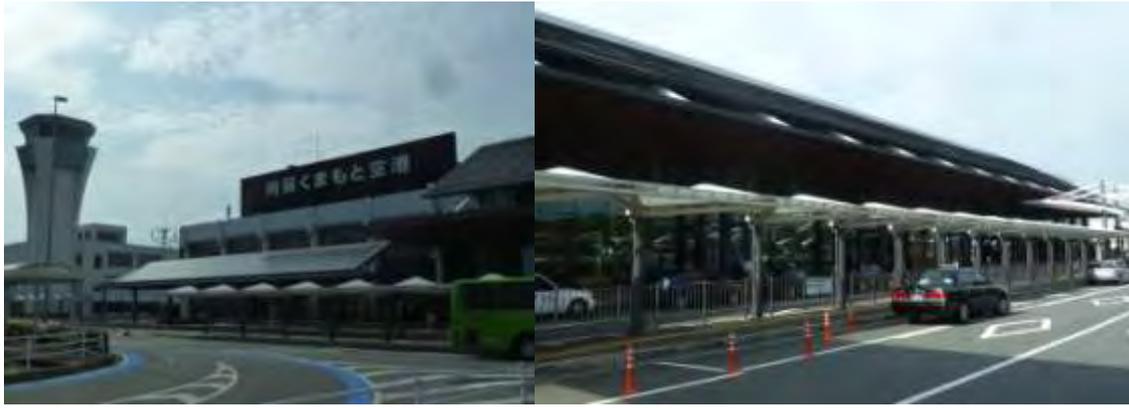
Exterior views of the newer steel framed Domestic Terminal building. The control tower is to the left. There was no obvious significant structural damage.

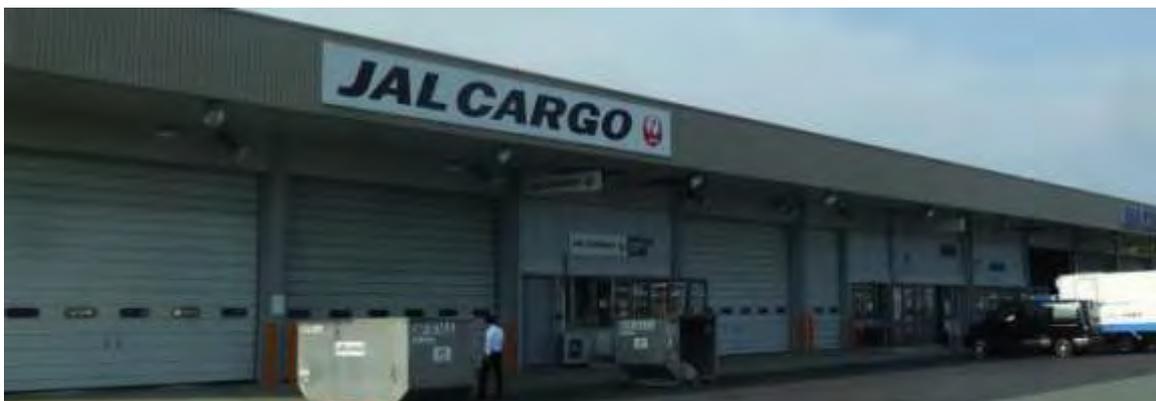
The airport included several steel framed cargo warehouses, hangars, and other service buildings. None of these appeared to have significant structural damage. That included older steel structures that were designed and built to outdated codes. Over time, and in many earthquakes these types of structures, have proven to be much lower risk than comparable concrete frame, precast or tilt-up, and shear wall structures.

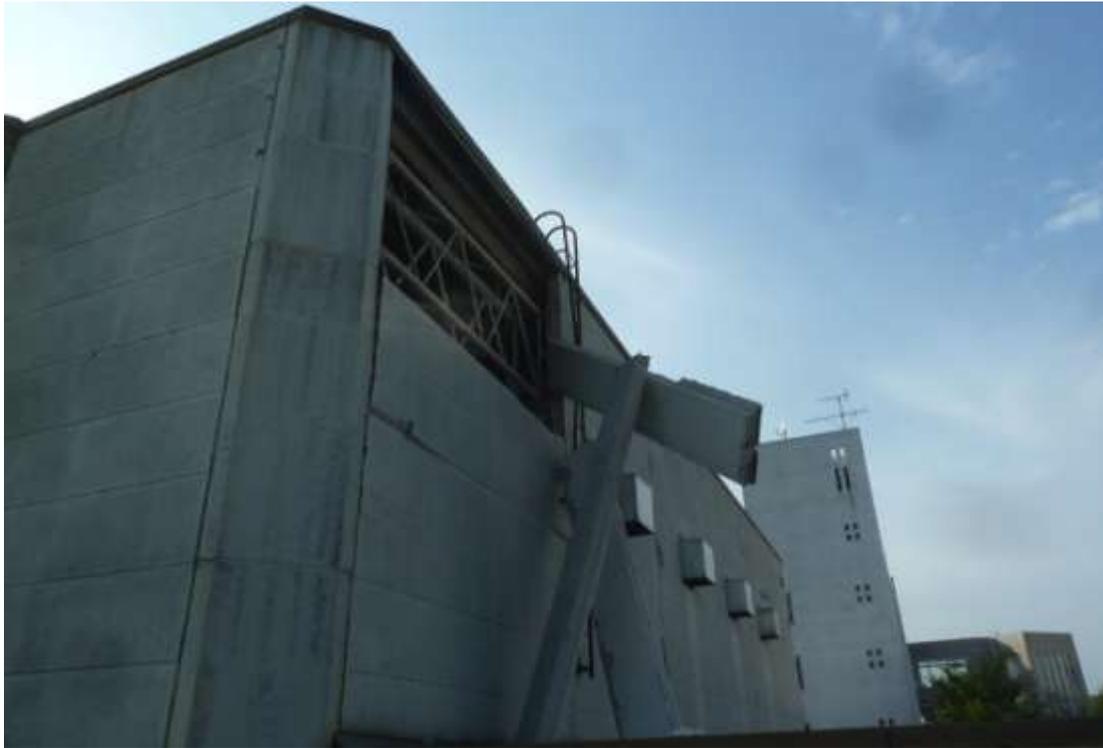
Damage to an older building at the airport training facility, where inadequate attachments for the heavy precast horizontal concrete cladding failed. I have observed this type of failure many times in earthquakes in Japan and elsewhere around the world. Typically, older buildings with these types of facades, as well as older precast concrete buildings, are much higher risks than comparable age steel framed and massive concrete shear wall buildings. Several other similar buildings at the airport had comparable, but less dramatic, damage.

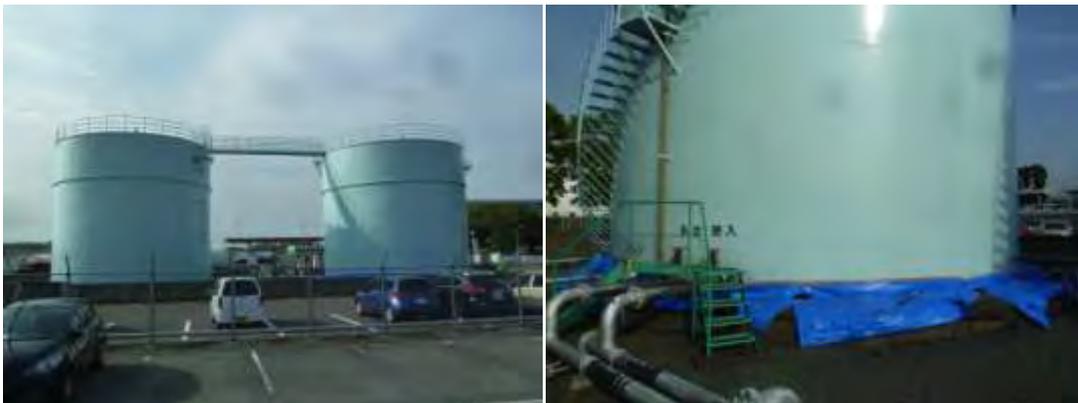
At first glance, this aviation fuel storage facility at the airport appeared to have suffered damage to one of its two tanks. It turned out that the blue plastic tarps covering the effects of the earthquake were providing temporary cover replacing the damaged asphalt waterproofing around the tank base. The damage was inconsequential. Generally, equipment such as this had adequate anchorages and performed well.

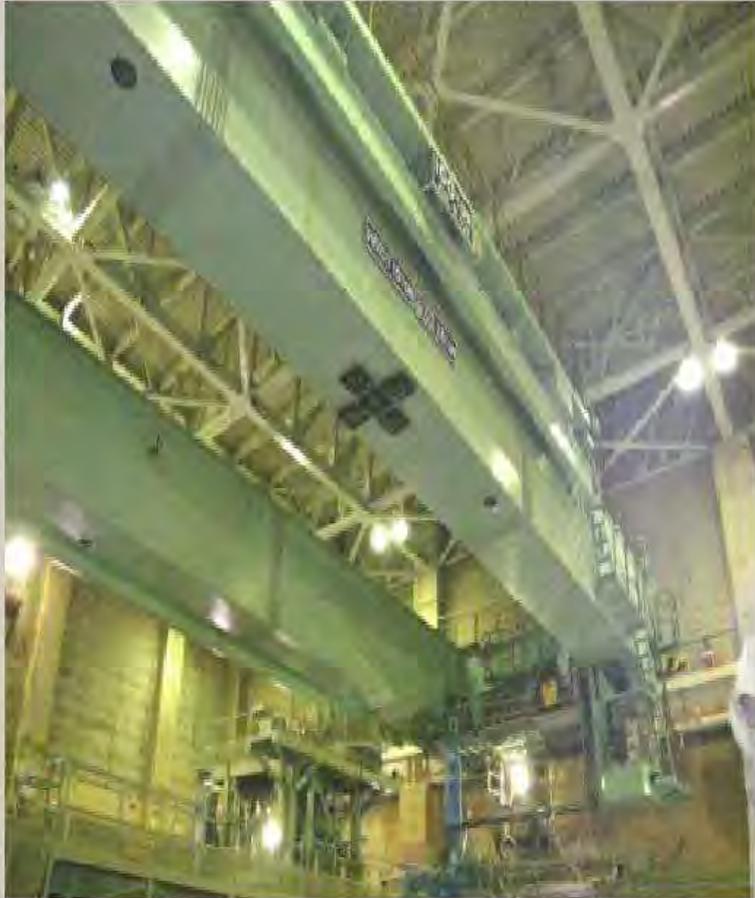
100001-1 Overhead Crane

The crane would have been parked at the far end of the high bay as Unit 1 was in operation. Crushed particles of roller bearings for the rail wheel axle assemblies were found spilled in the oil trays at the bottom of the wheel assemblies.

Basis for Assuming Post-Earthquake Operability: The crane was moved following the earthquake, but found to have excessive vibration and noise due to the damaged bearings noted above. Subsequent operation of the crane has been postponed pending repair.

The crane itself is a major interaction hazard. The crane did not dismount from the rail.
