Fosterville Gold Mine

OHSF-MPL-003

Bush Fire Mitigation Plan

2023-2024

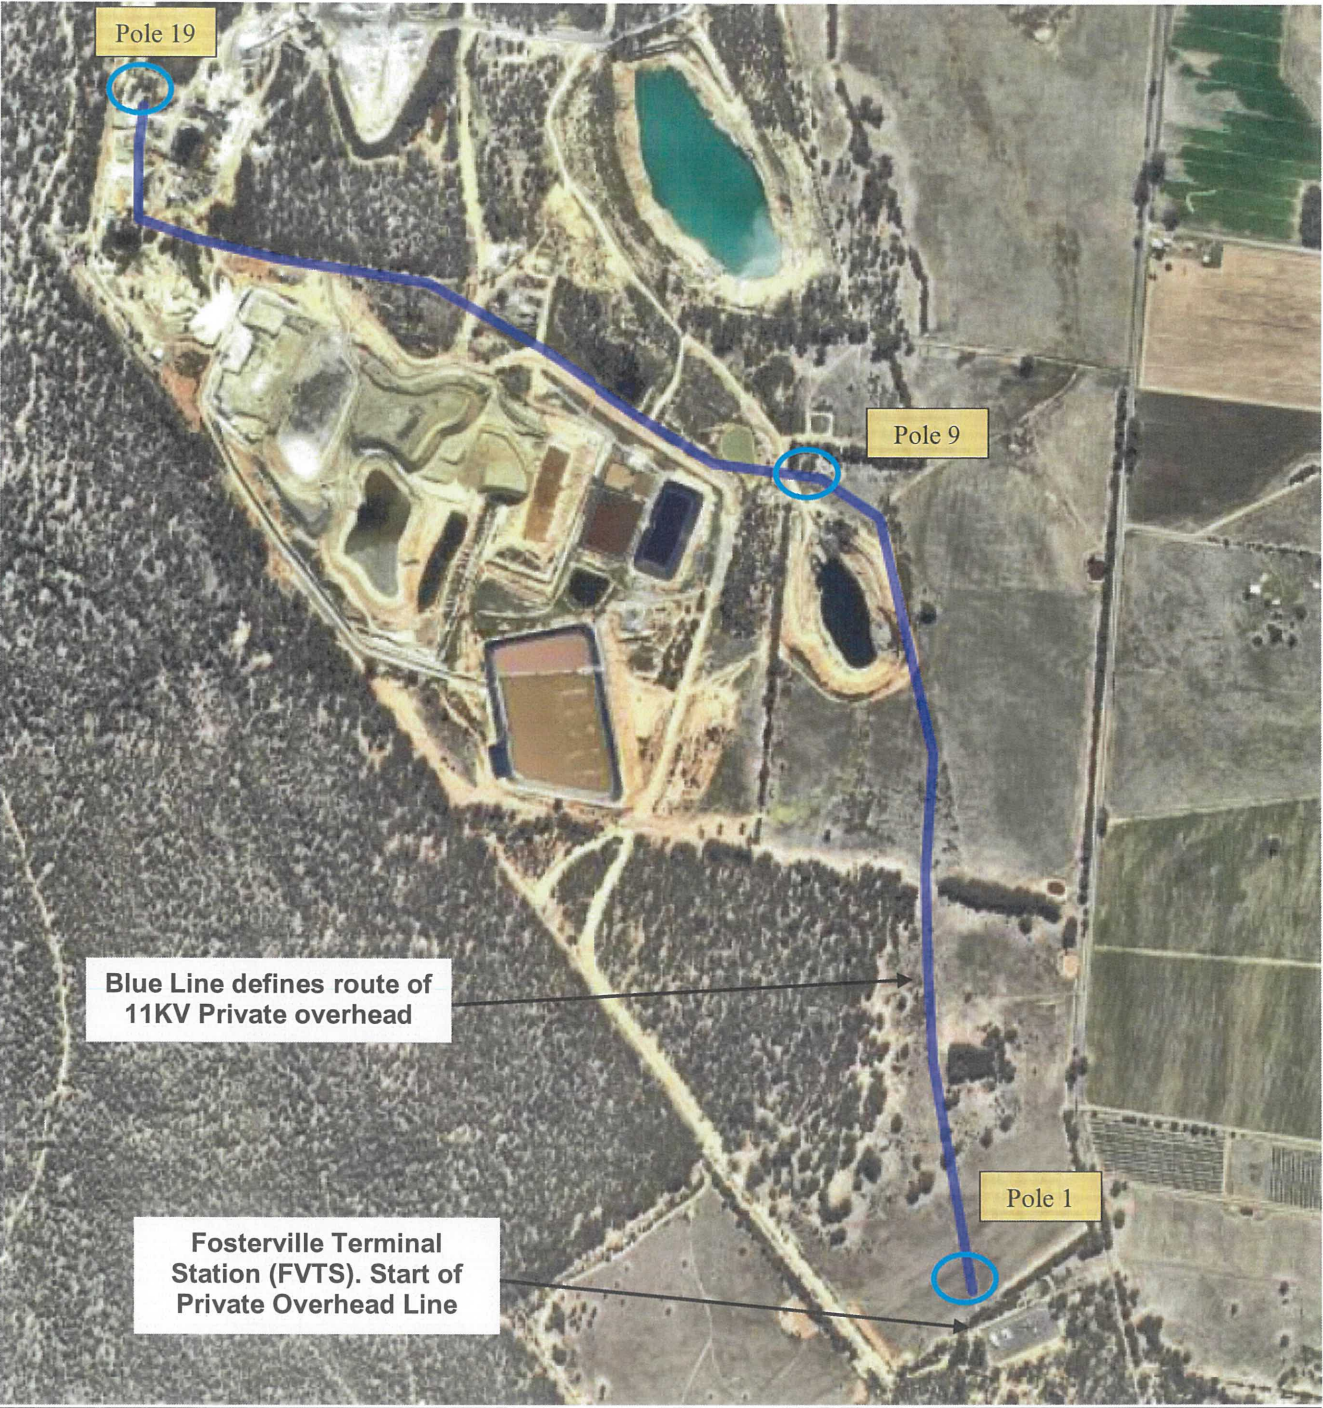
Image - 1

The image below shows the 11kV power line route from FVTS Pole 1 to Pole 19.
